October 29 - 30, 2014 | Wolfville, Nova Scotia

EVALUATION OF COVER SYSTEMS UTILISING GEOSYNTHETIC LAYERS FOR CLOSURE OF COAL WASTE ROCK PILES IN A SEASONALLY HUMID LOCATION

***Authors: Greg Meiers - P.Geo.
Mike O'Kane - P.Eng.
David Mayich - CET***

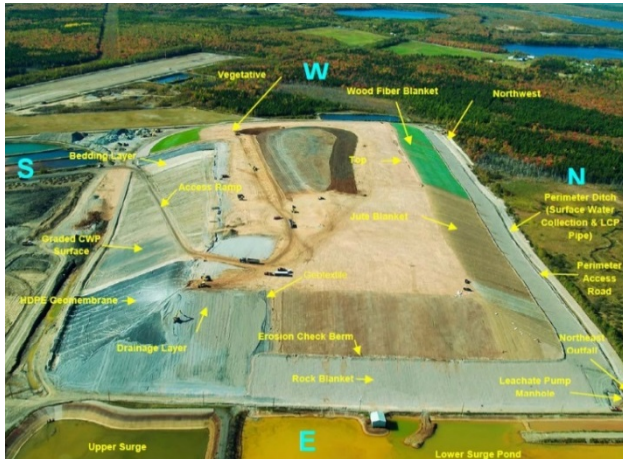
Background – Victoria Junction

- Covers an area of 26 ha
- Height of 30m
- Plateau ~7%
- Side Slope 3:1
- Ditch constructed around plateau which channels runoff and interflow to drop structures on side slope

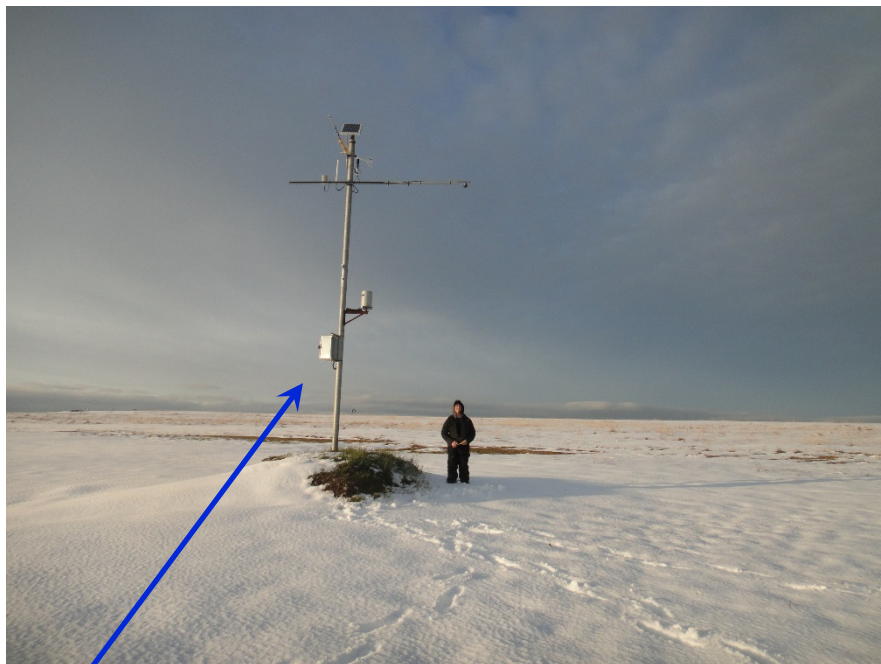
- **Monitored Climatic Parameters *at each Site*:**

- **Installed multiple net radiometers (north aspect)**

- **Snowpack (i.e. SWE) measurements
Automated and manual**

***Fully Automated
Meteorological Station***

***Calculate Potential
Evaporation***

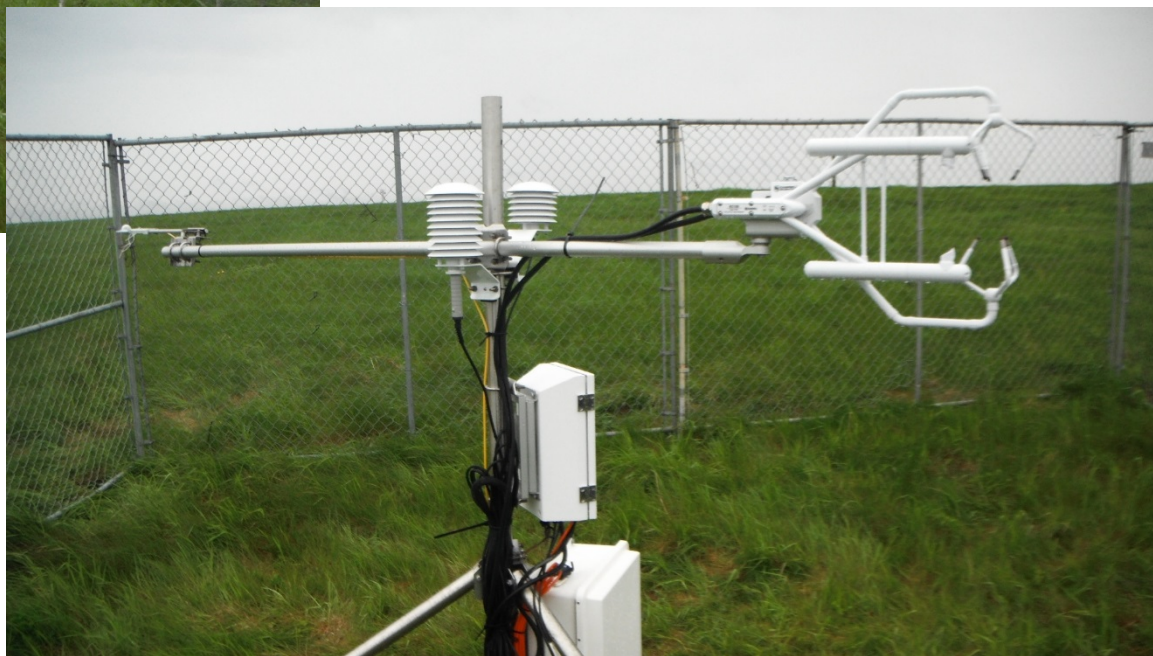
***Eddy Covariance Station
(direct measurement of AET)***

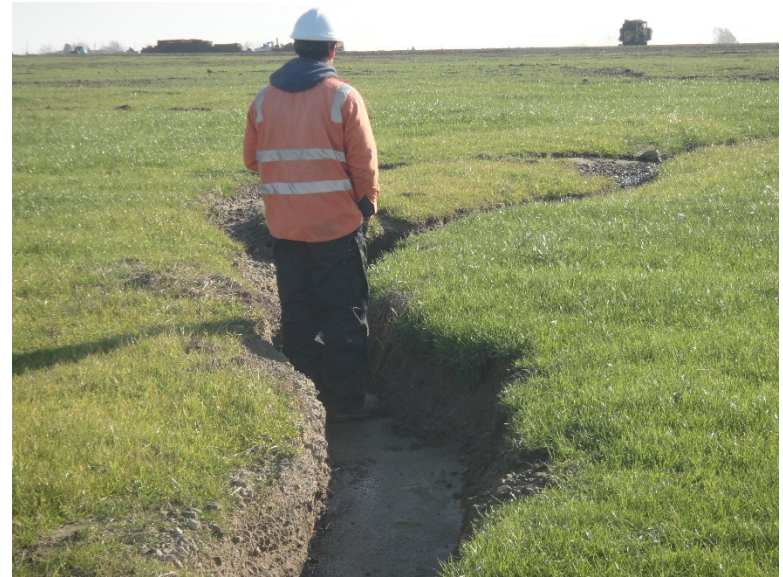
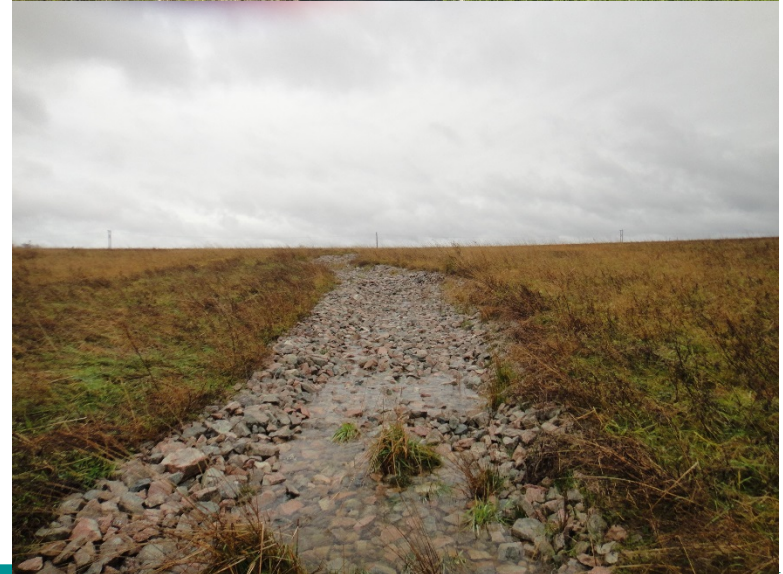
Monitoring Data - **Summit**

Long-Term Erosion

Severe erosion hazards zone -
revegetation improbable.

Critical erosion hazards zone -
revegetation success poor.

Moderate erosion hazards zone -
revegetation success fair.

Moderate erosion hazards zone -
revegetation success good.

Moderate erosion hazards zone -
revegetation success very good.

Slight erosion hazards zone -
slope influence minimal.

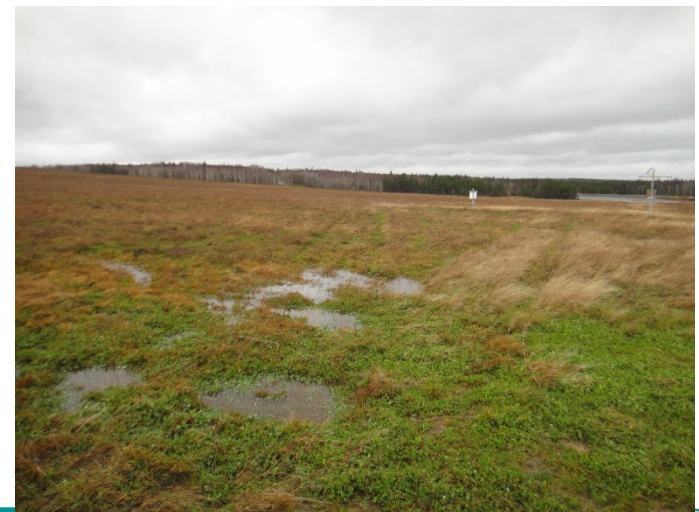
Monitoring Data – *Victoria Junction*

- VJ granular drainage layer is drained, minimizes potential for leakage, maximize slope stability

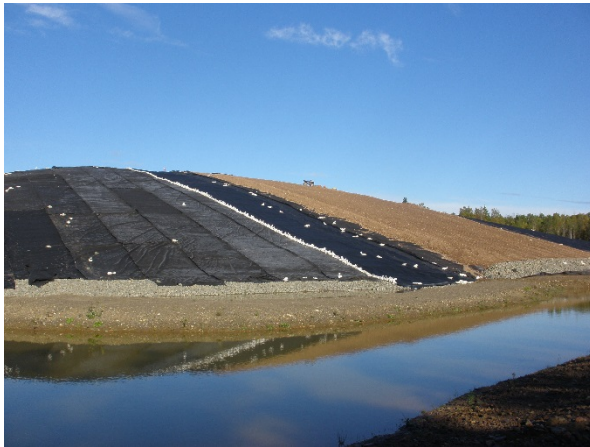
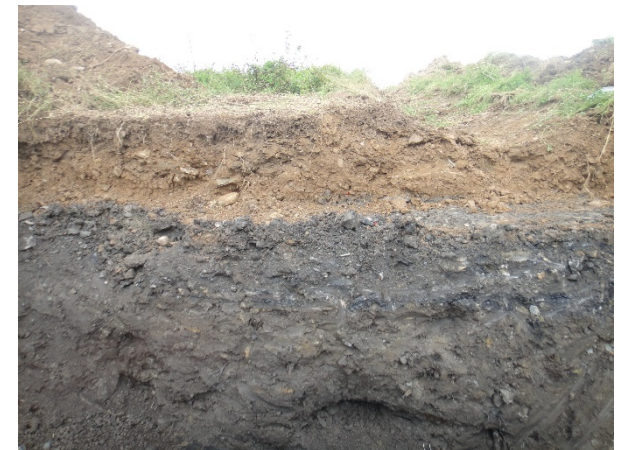
Cover System Type

Geomembrane

Growth Medium

<5%

10%

20%

30%

Range of Net Percolation Rates

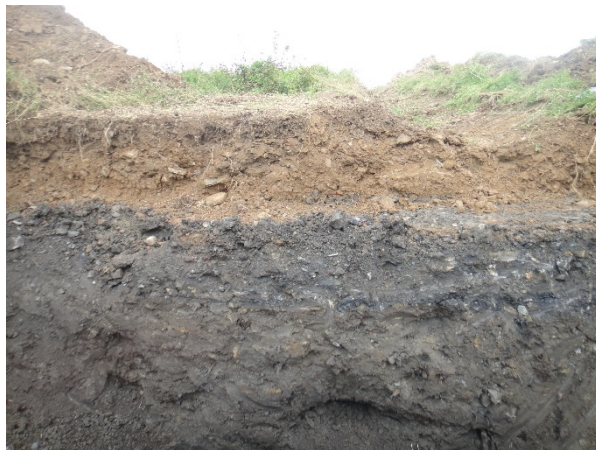
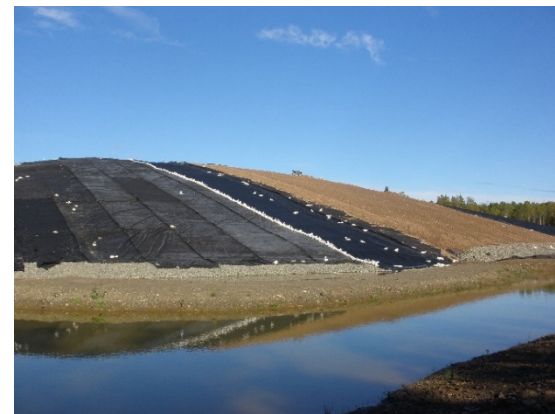
Cover System Type

Growth Medium

Geomembrane

20 to 30%

50%

60%

Range of Runoff Rates

**Moderate
Drainage Layer**

**High
No Drainage**
