Community Patterns after 5 Years of Salt Marsh Restoration in the Upper Bay of Fundy

By: **Allen Beck**¹, Laura Boone¹, Myriam Barbeau¹ and Nic McLellan²

The project at Aulac

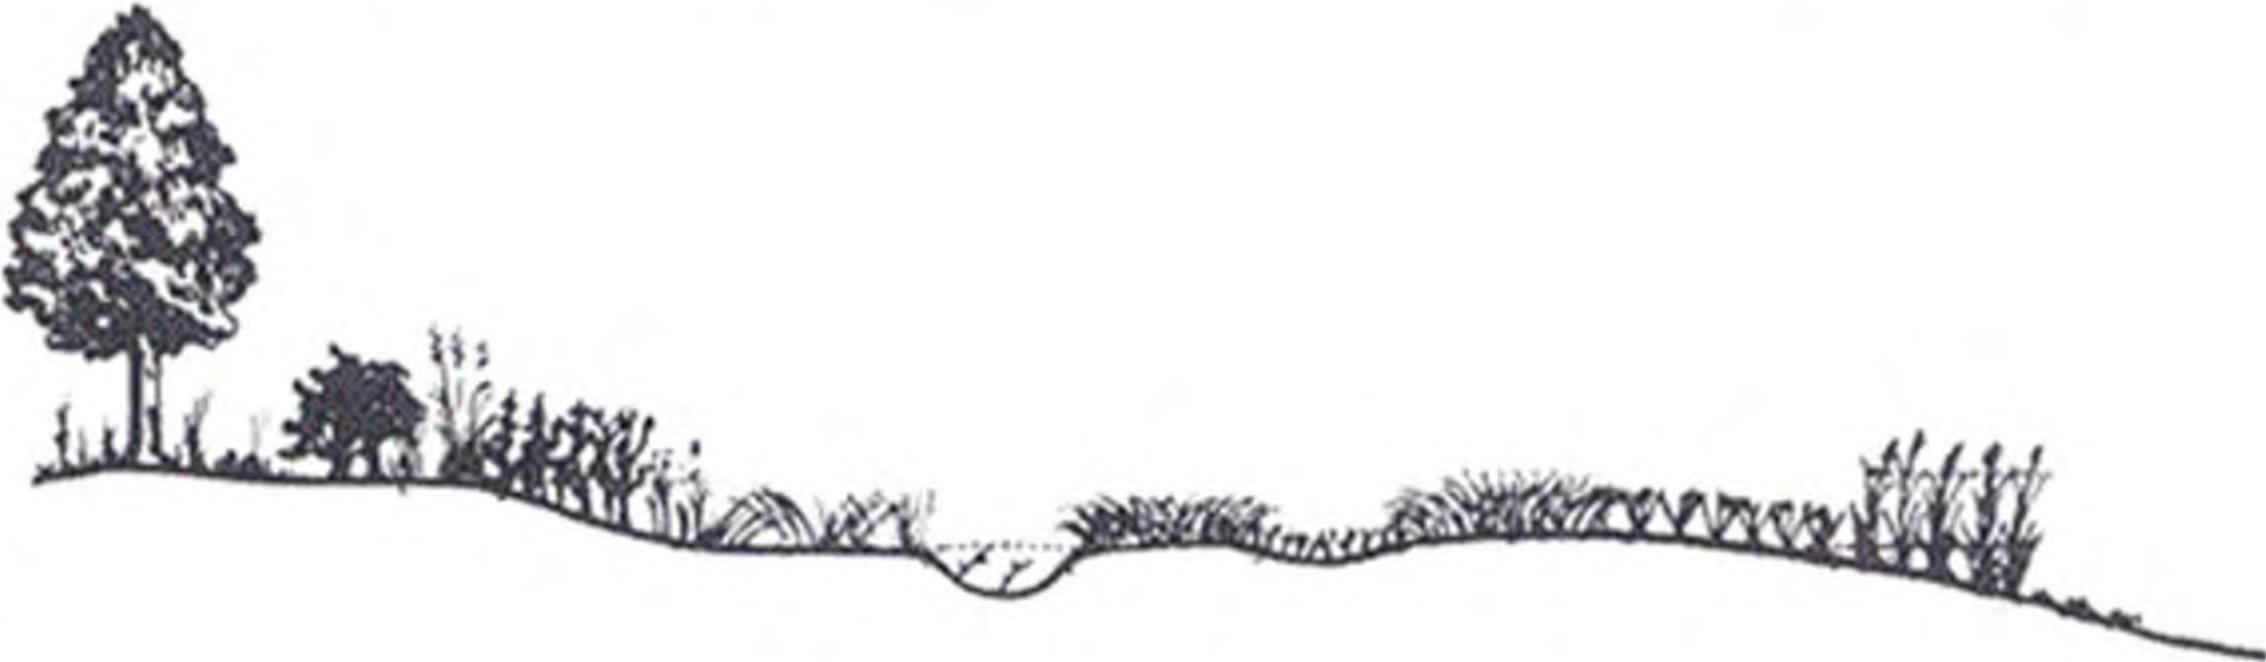
Salt marsh structure

Transitional zone High marsh Low marsh

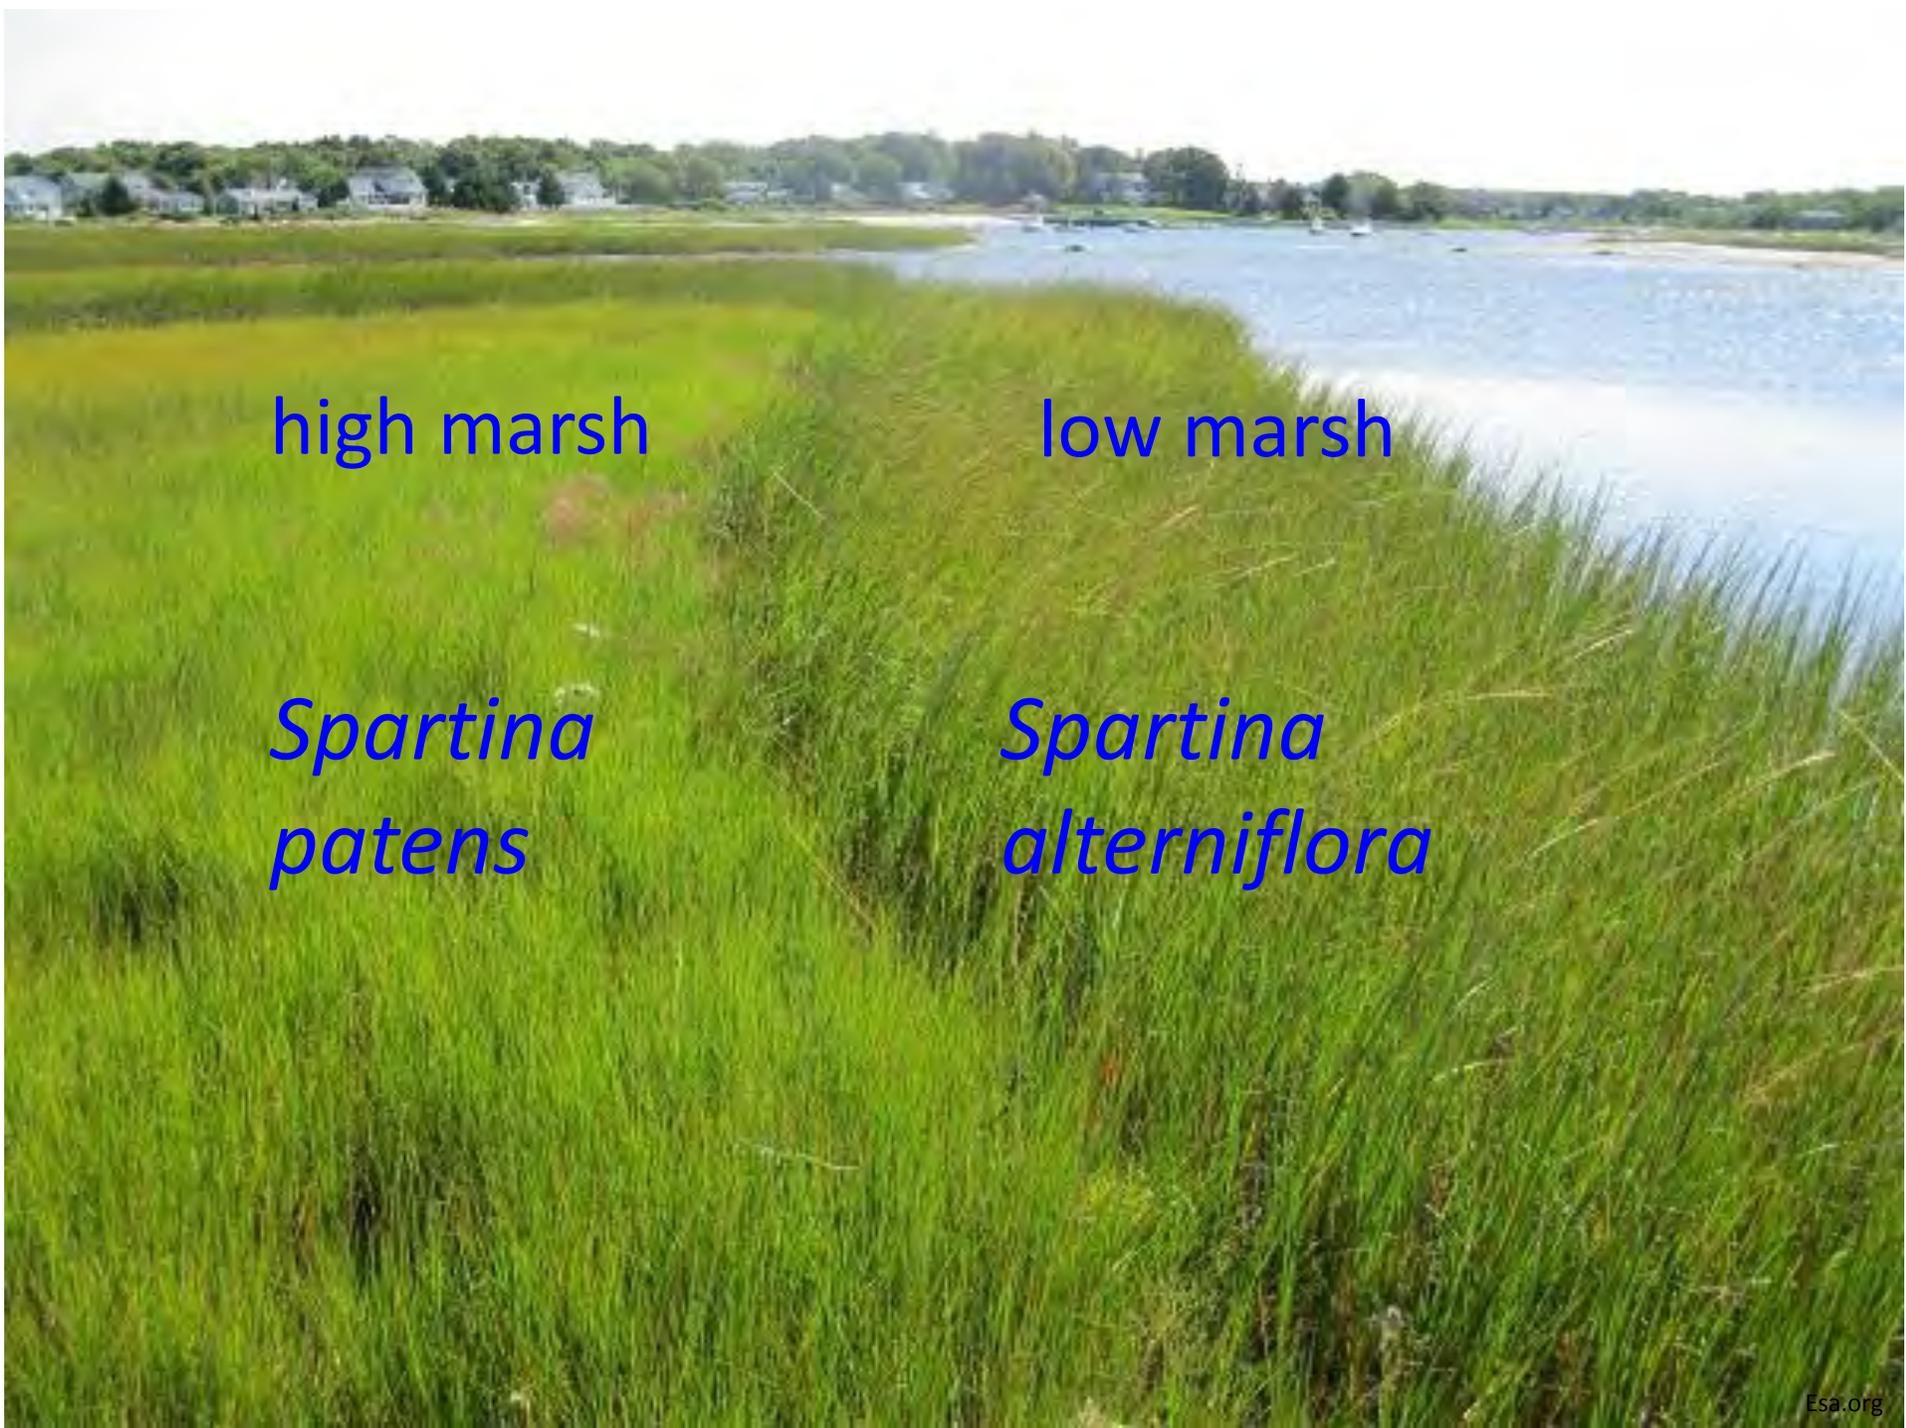
high marsh

low marsh

*Spartina
patens*

*Spartina
alterniflora*

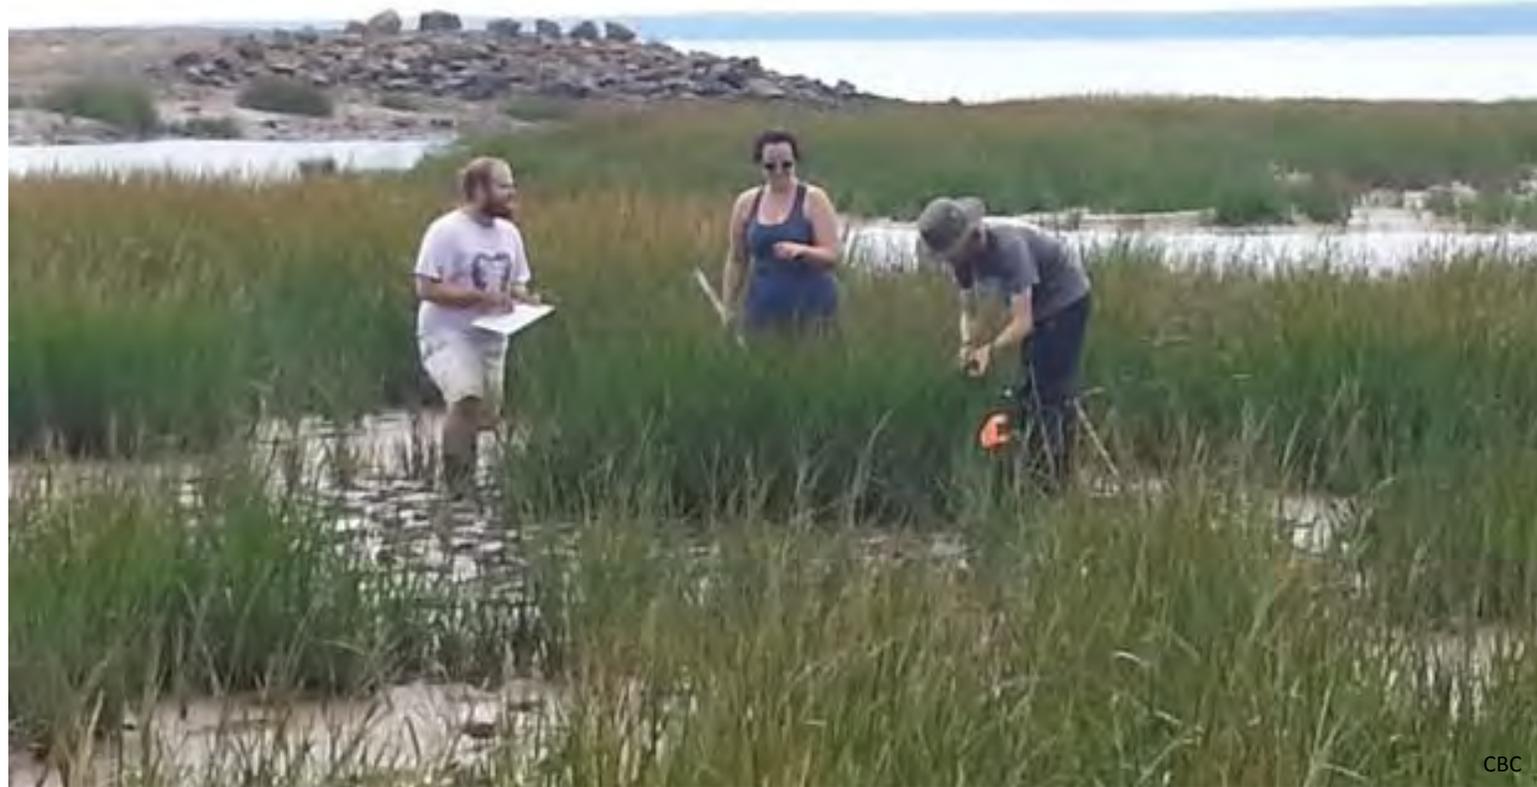
- 4 sites
 - Natural West/East
 - Impacted West/East
- 3 transects per site
- 15 quadrats per transect

- Densities of all emergent plant and invertebrates measured
- Each sampled annually since 2010 (June – August)
- 6 years of data

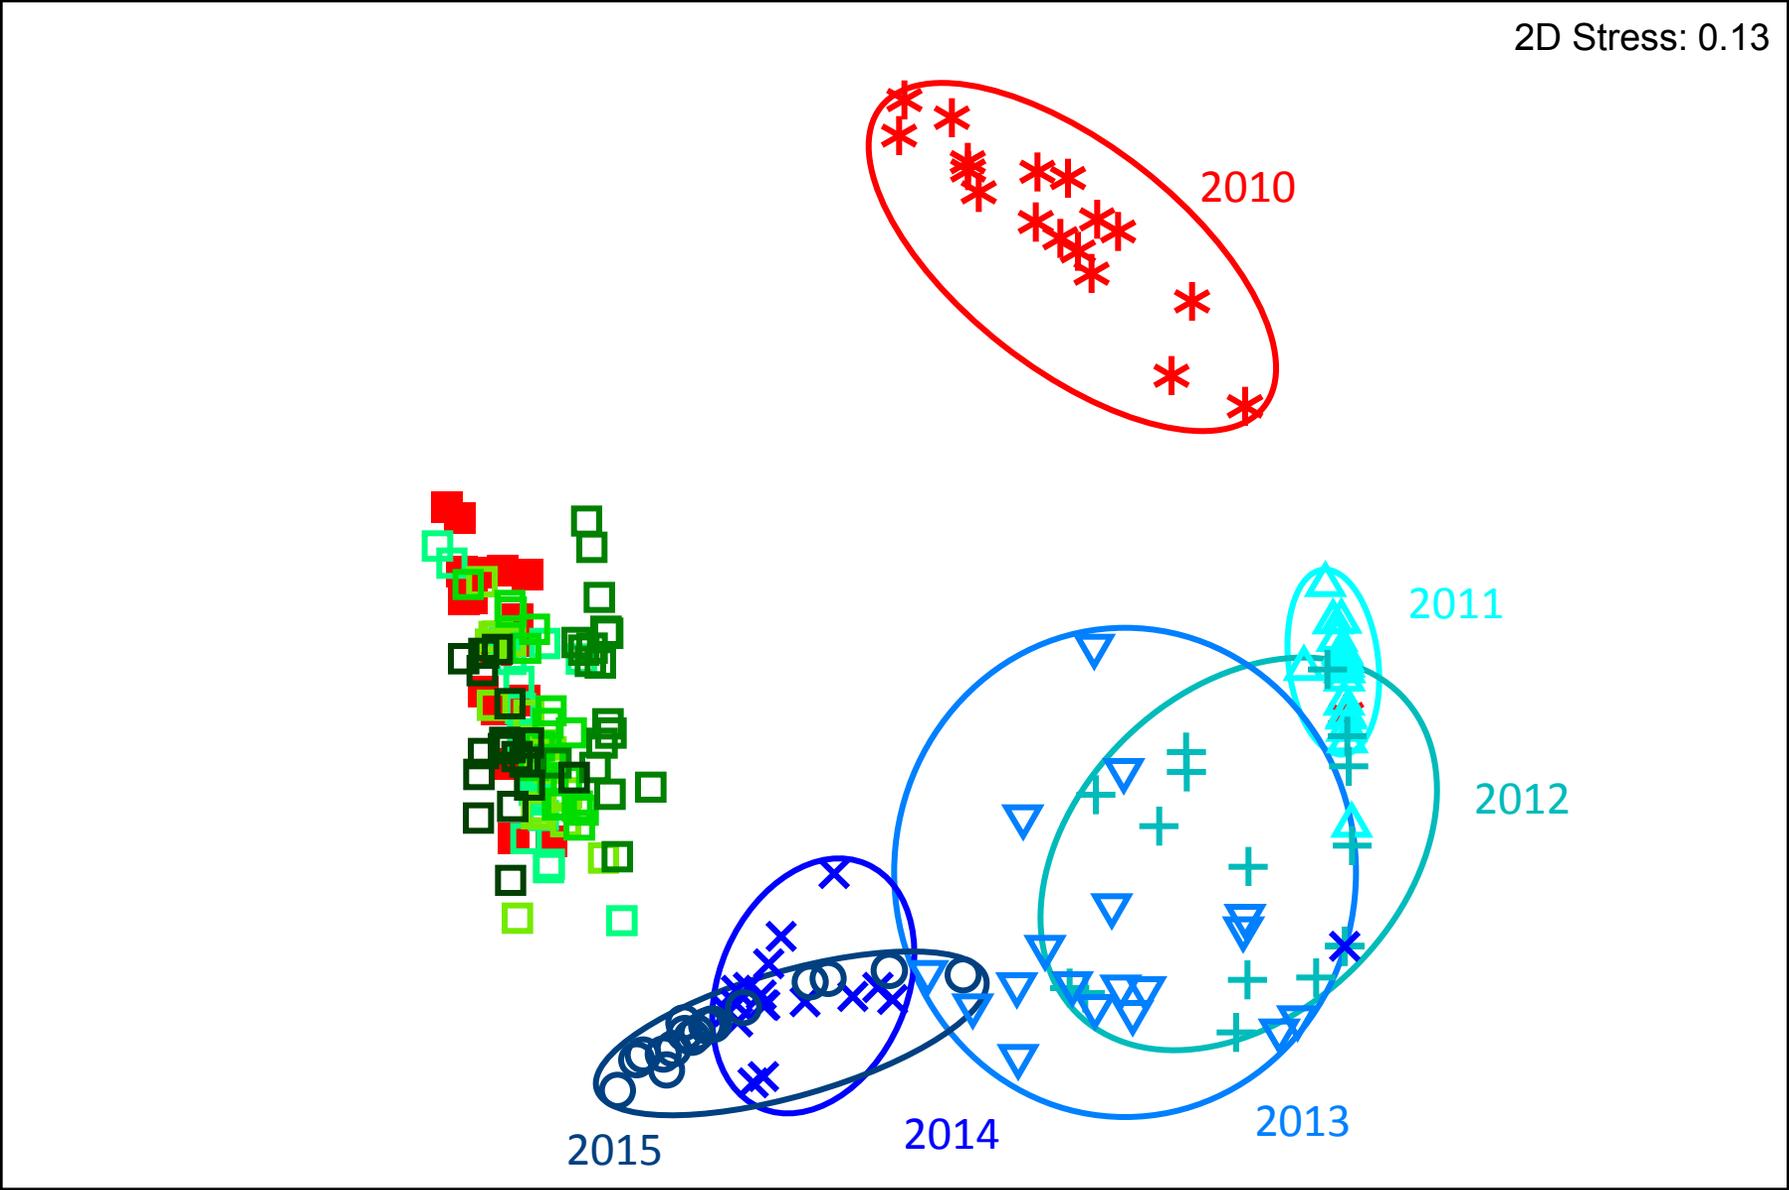
2010 – Pre-breach

Resemblance: S17 Bray Curtis similarity

2D Stress: 0.08

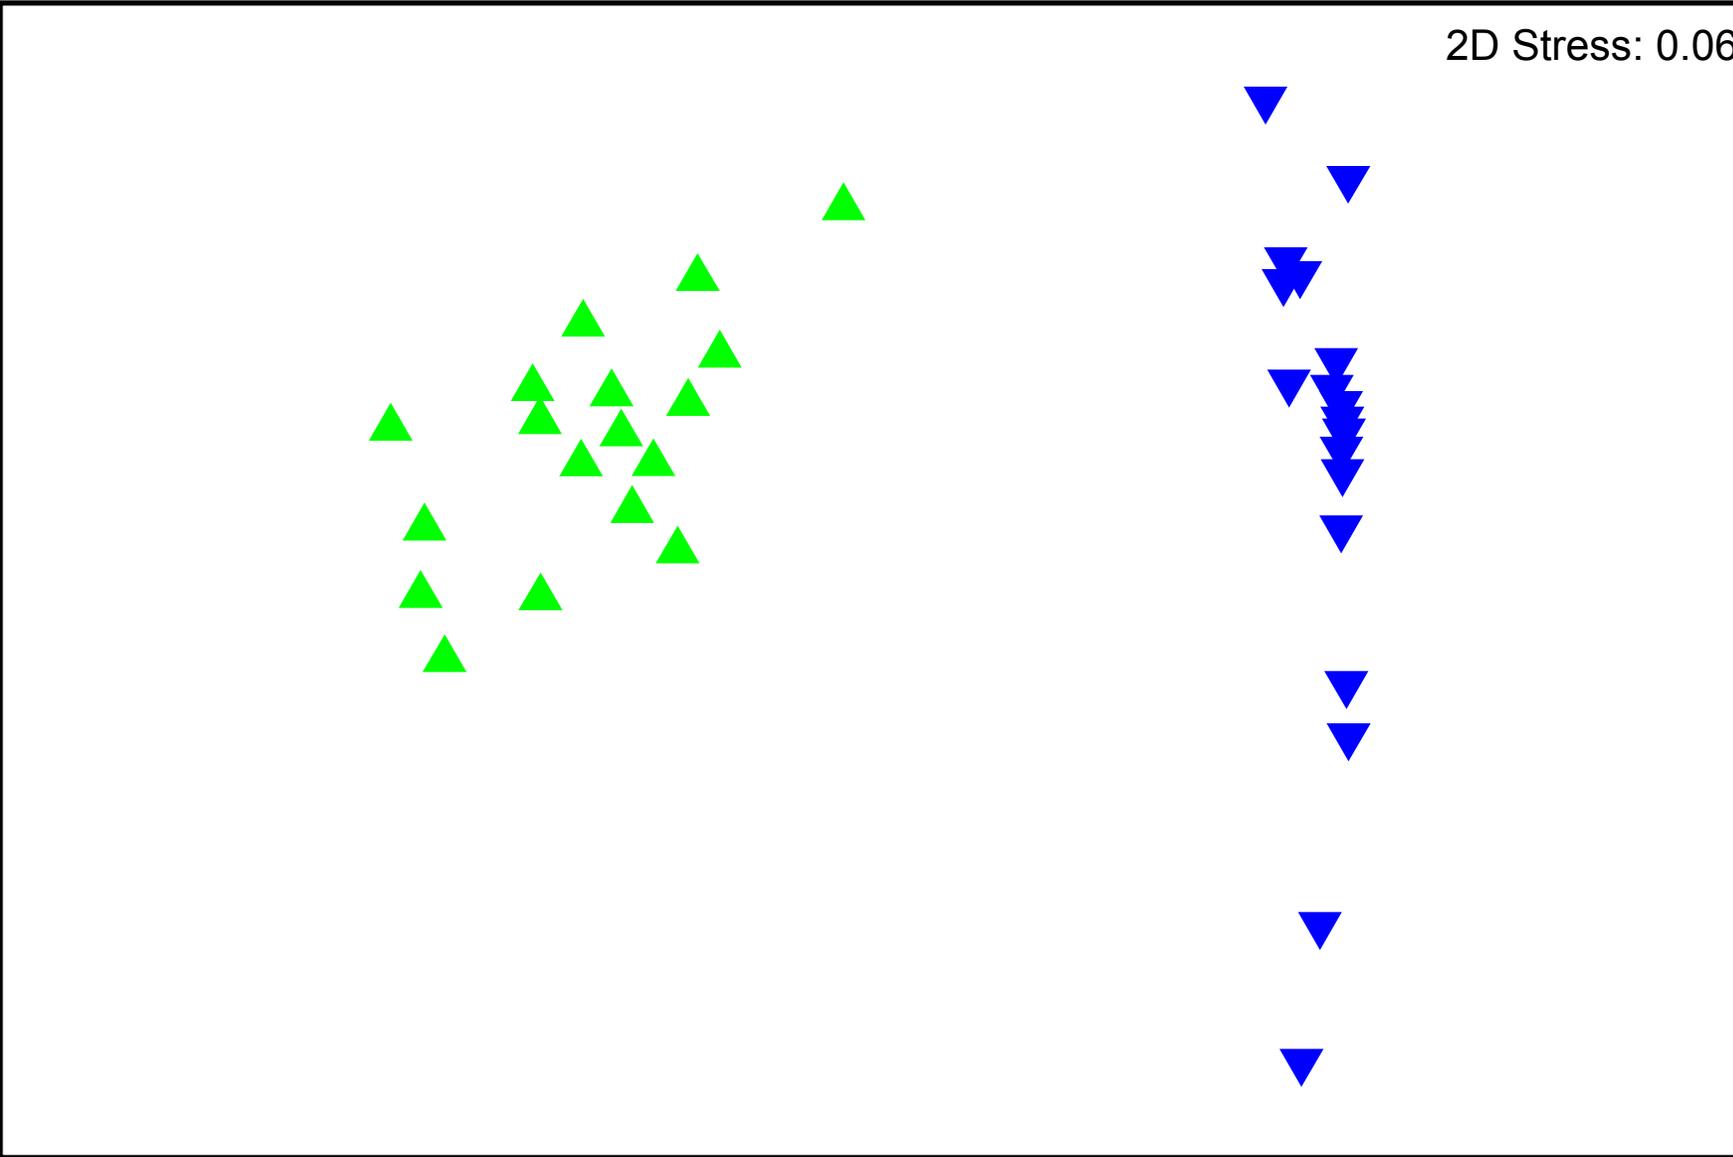
2015 – 5 years post-breach

Resemblance: S17 Bray Curtis similarity

2D Stress: 0.06

Type

- ▲ Natural
- ▼ Impacted

symbol = transect

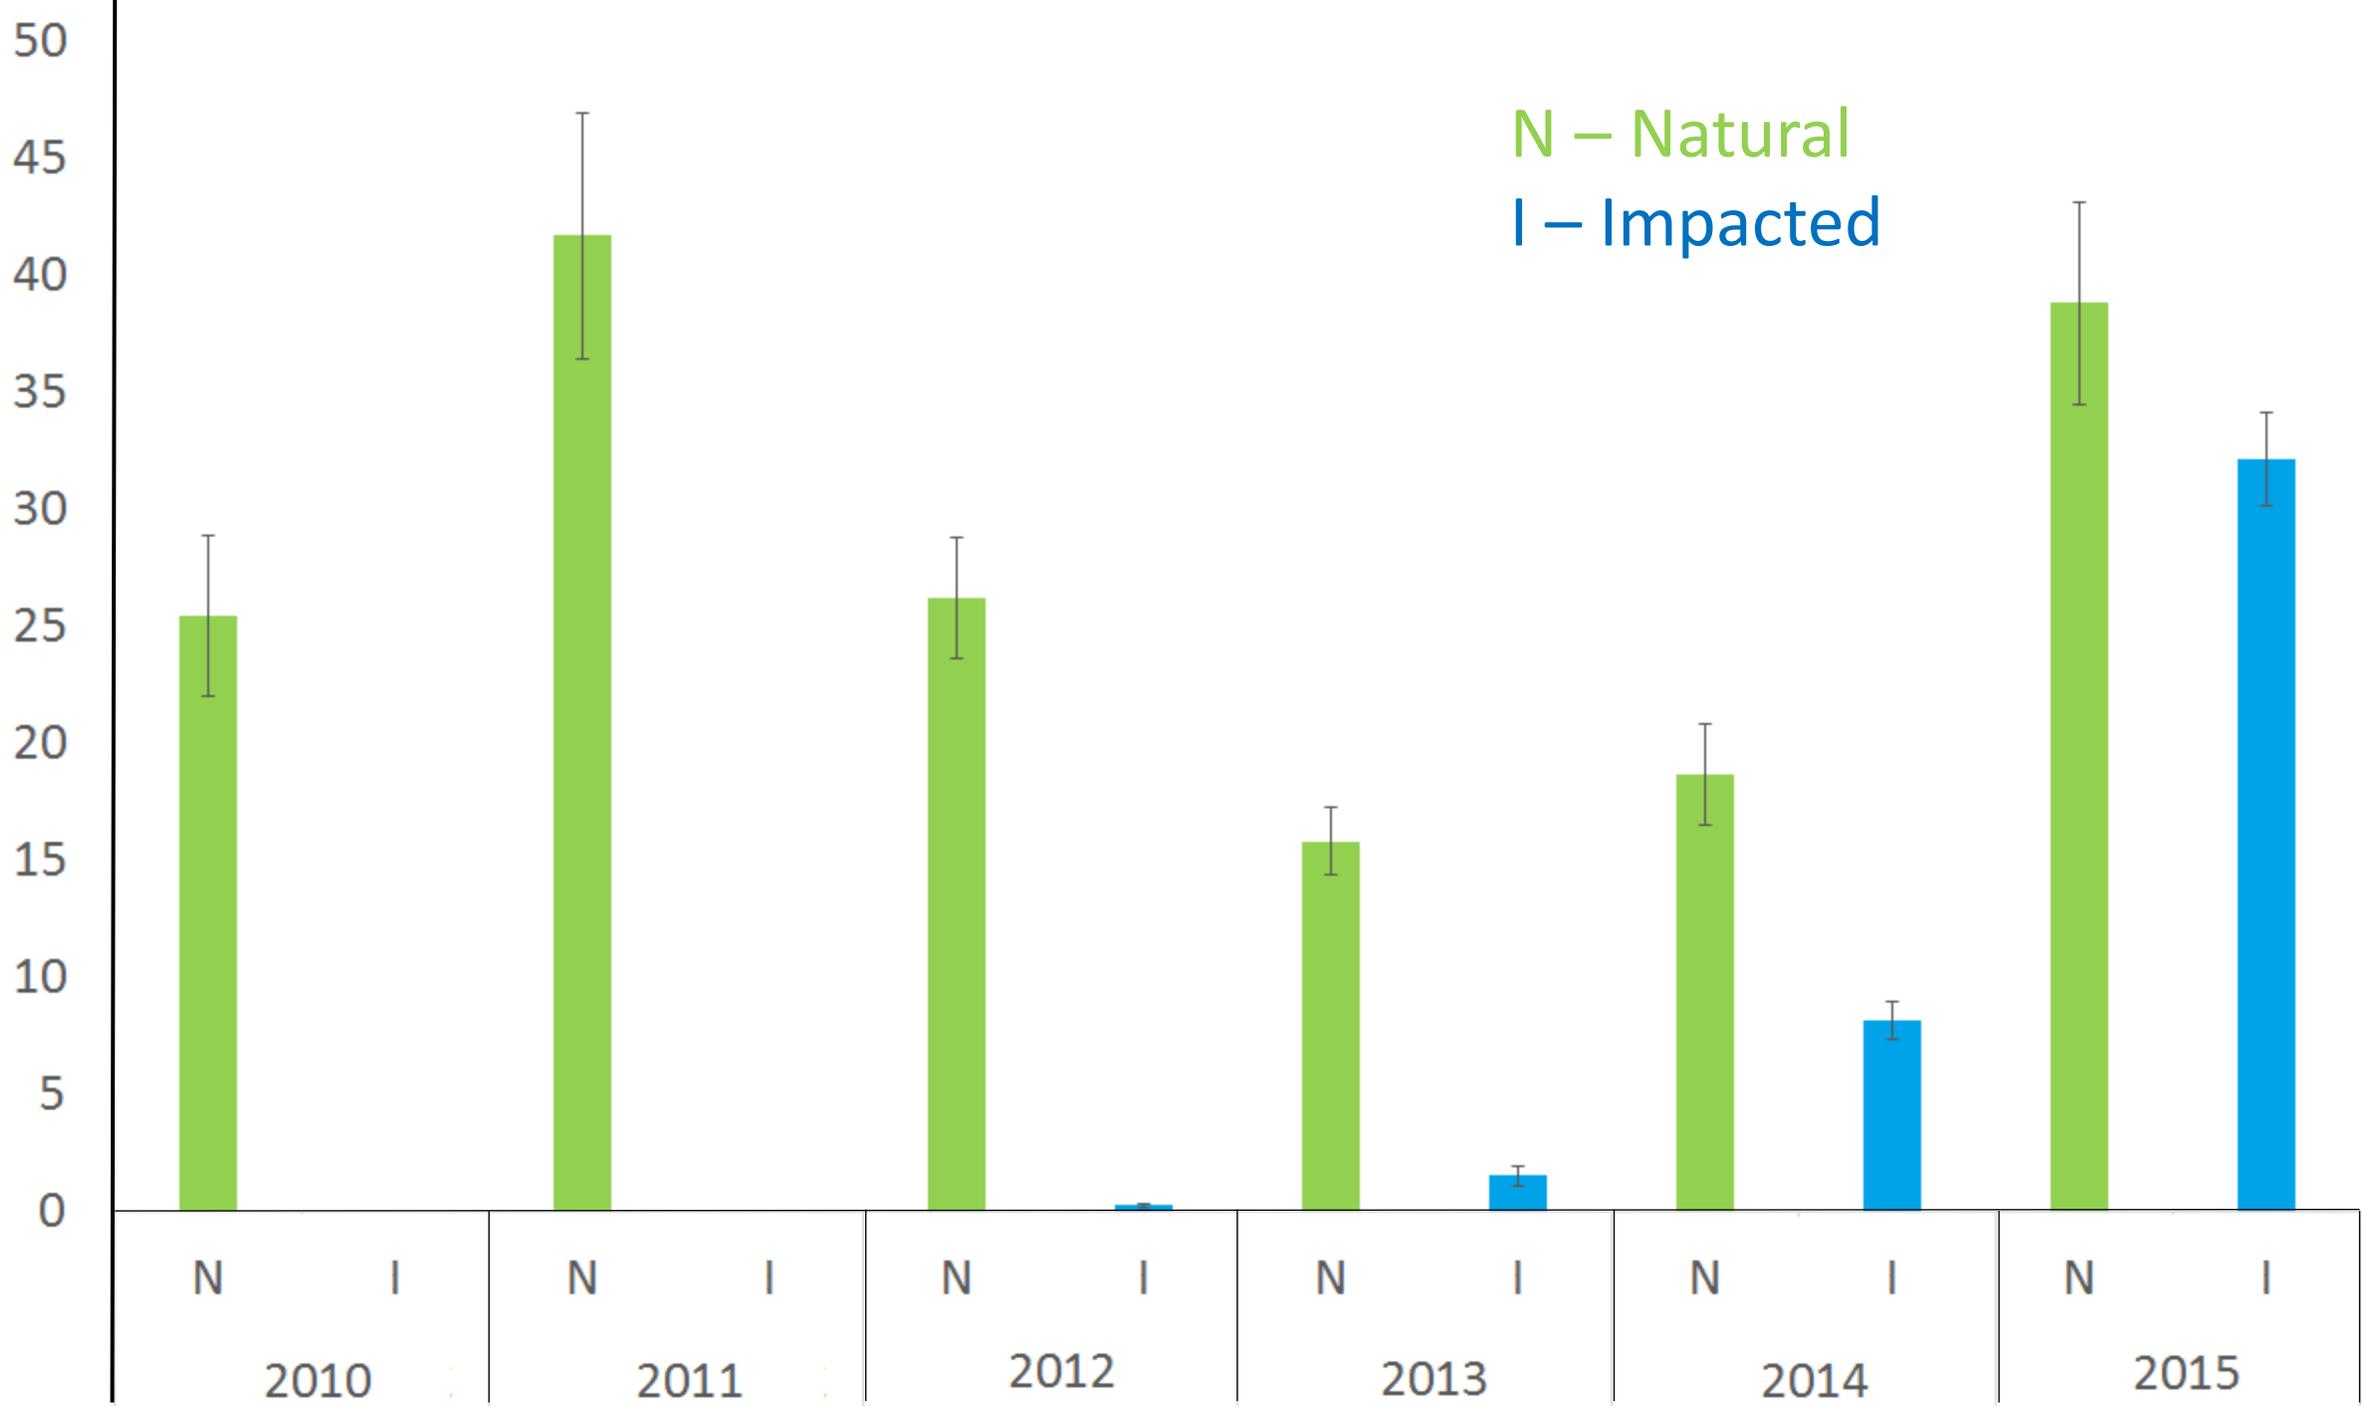
Spartina alterniflora/0.25m²

N – Natural

I – Impacted

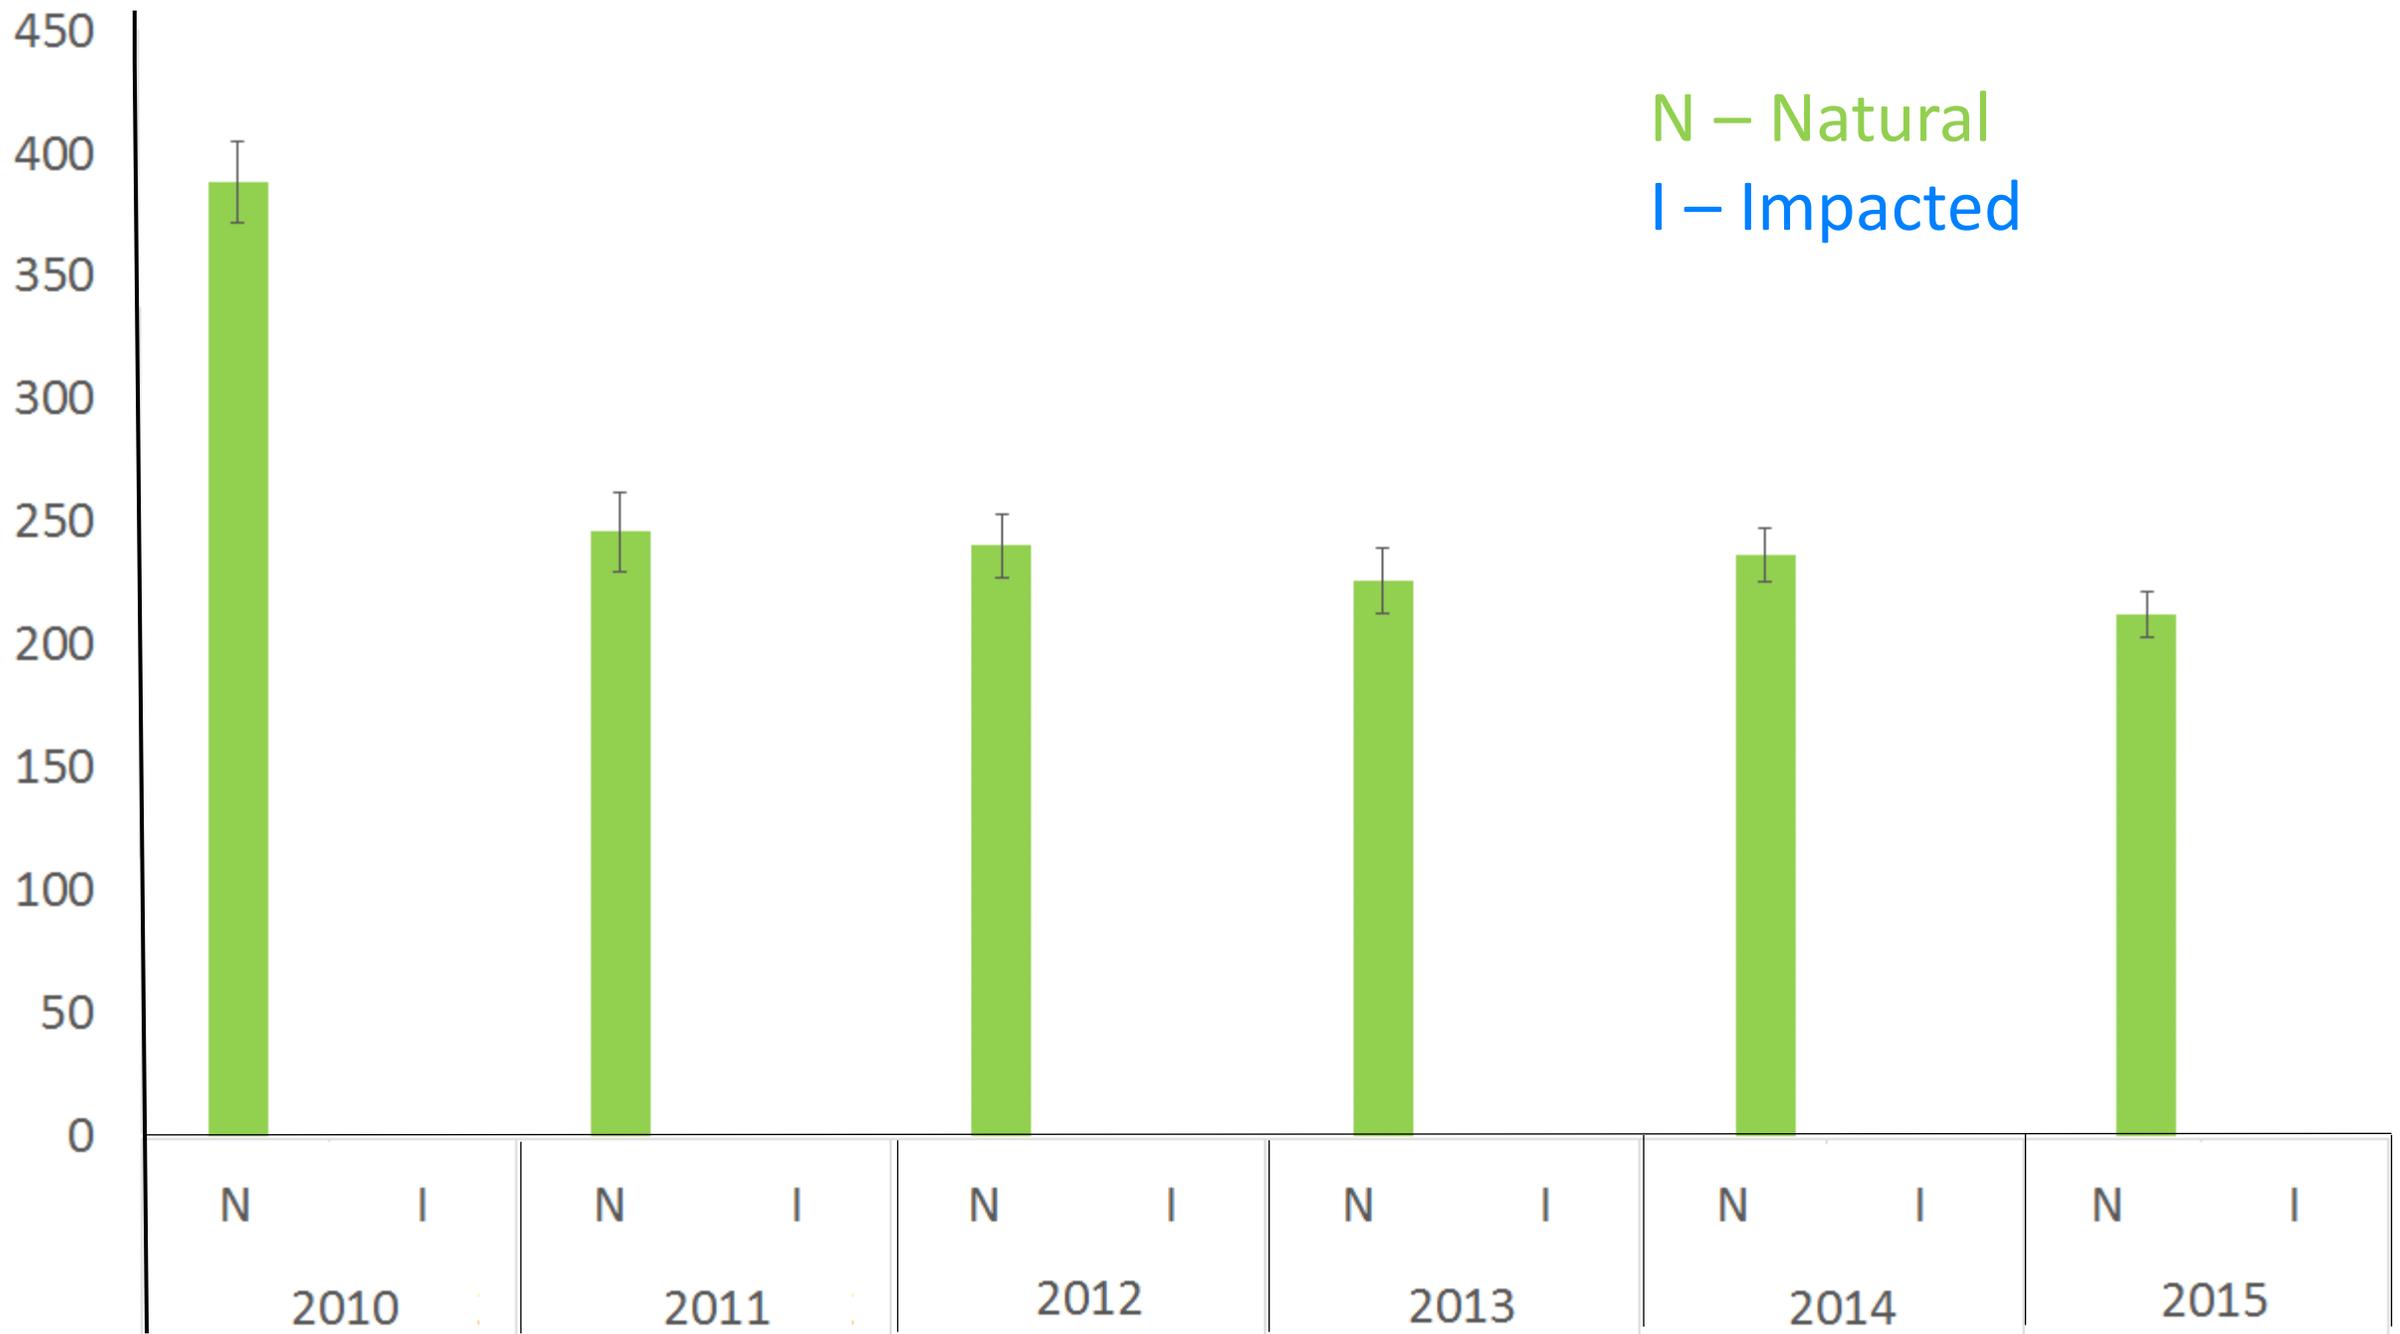
Spartina patens/0.25m²

- Community structure at impacted sites becoming similar to natural sites
 - *S. alterniflora* effectively spreading throughout impacted sites
 - Still no *S. patens* present in impacted sites
- We expect *S. patens* to establish itself in the impacted sites once the marsh elevation is high enough (due to sedimentation)
- In the upper Bay of Fundy, salt marsh restoration requires more than 5 years
