A look back over ten years of tidal wetland restoration in NS

Tidal Wetland Restoration Projects

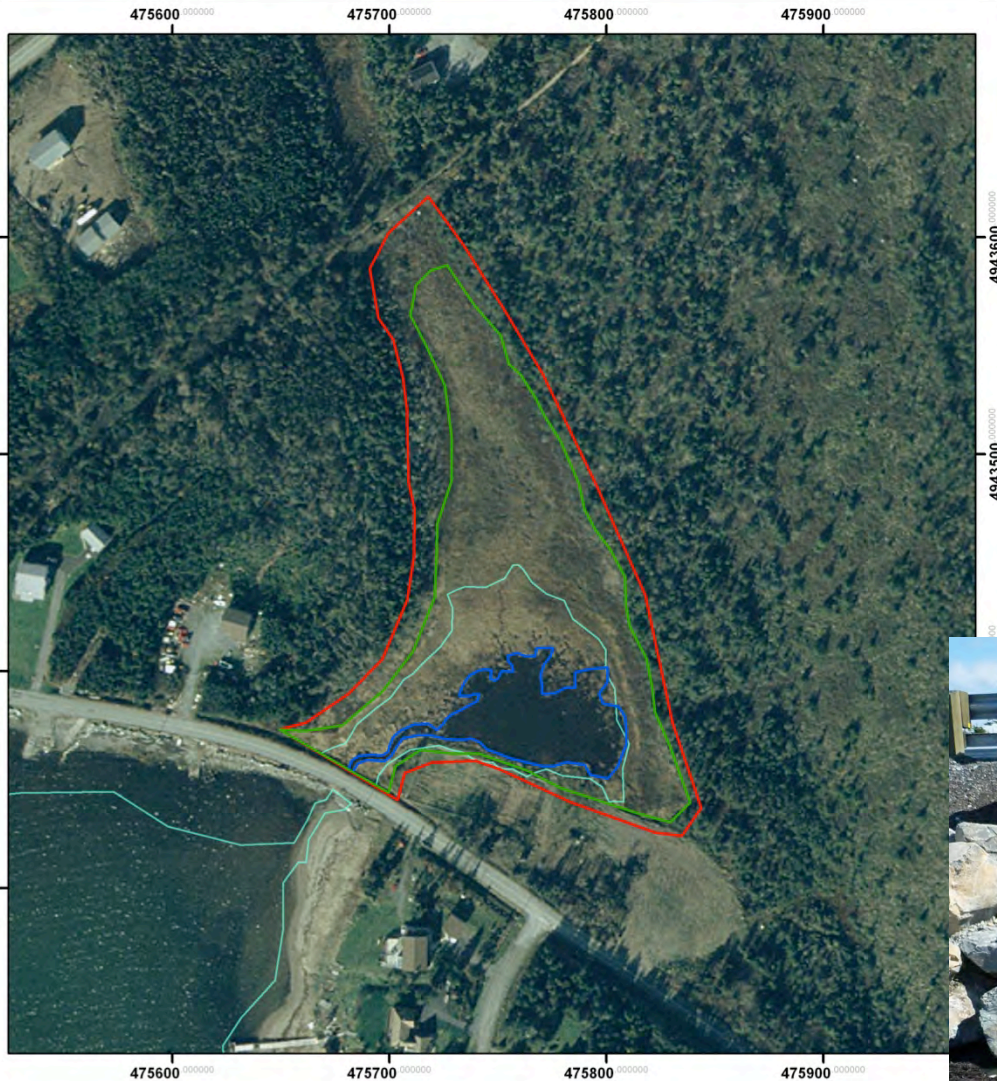
Three Fathom Harbour Habitat Map 2011

- Mean water level (0.74 m, May 25 - June)
- Unvegetated pond area
- Shrub-dominated wetland
- Study site boundary

UTM Zone 20N, NAD83
Tide level recorders deployed 25/05/2011-16/06/2011
Aerial Photography Oct/Nov 2003, DNR Canada

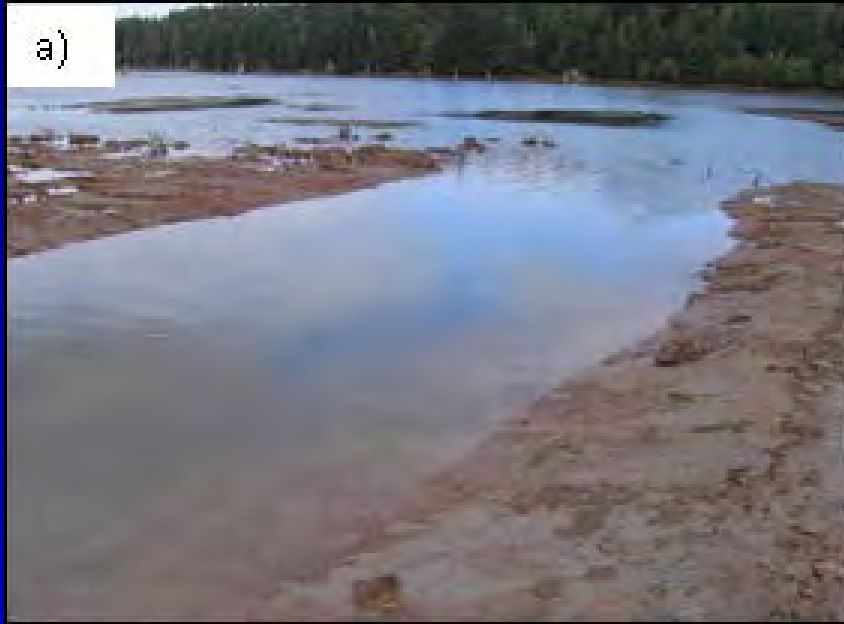
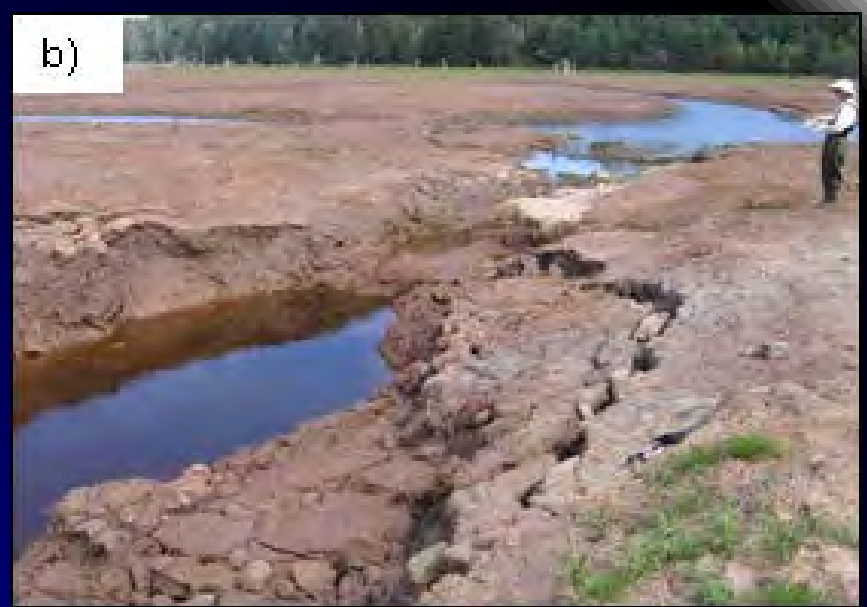
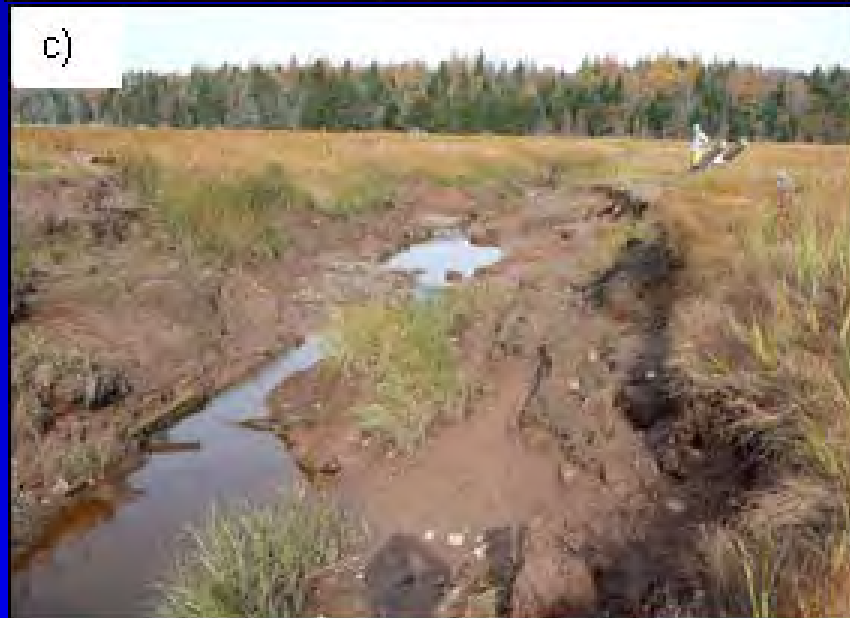
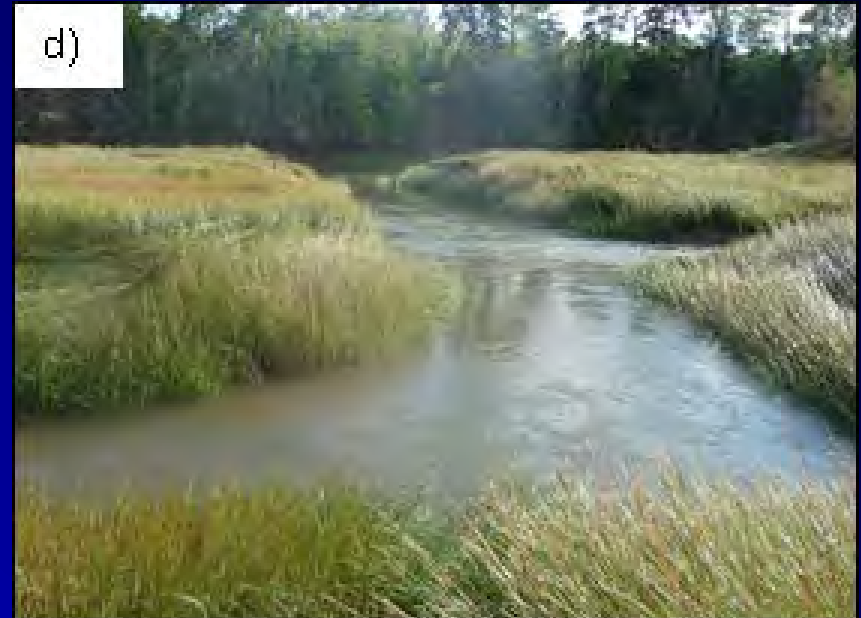
Main channel development at the second breach of WAL in a) fall 2005, b) spring 2006, c) fall 2009, and d) fall 2010 (ebb tide).

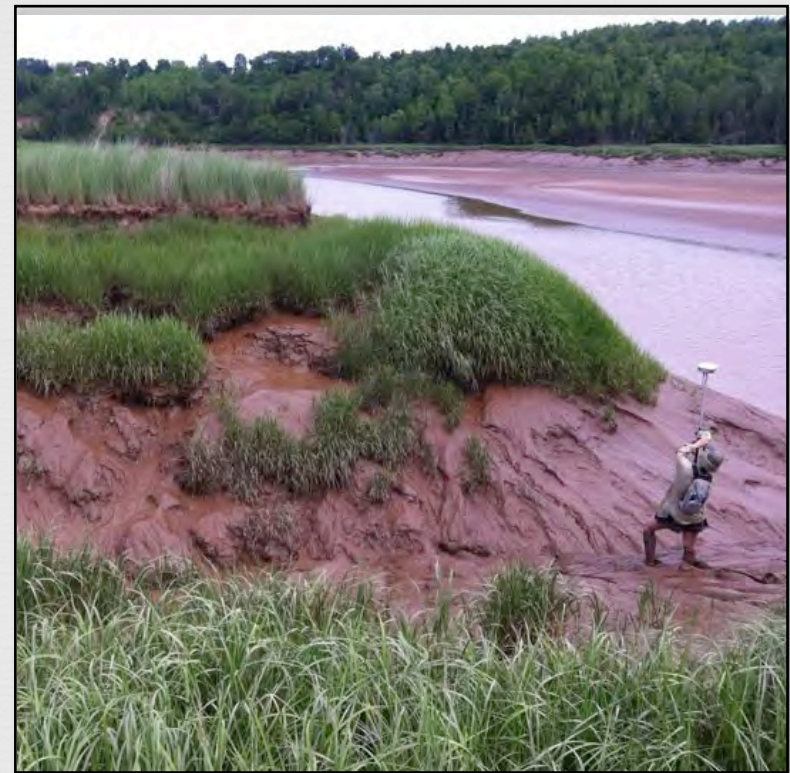
RTK channel profile on Kennetcook River

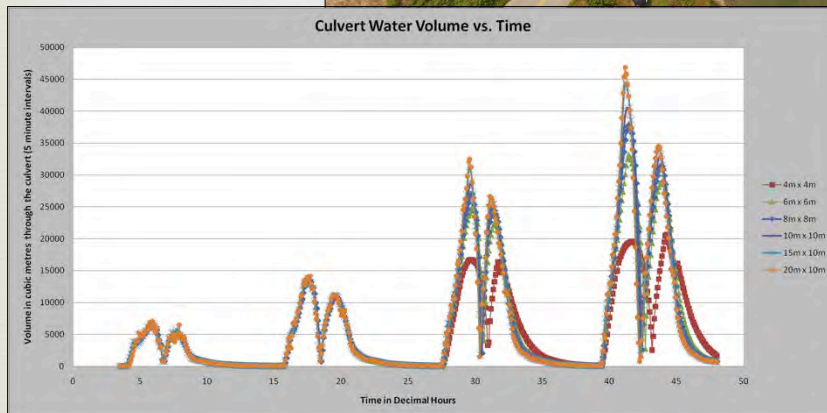
Hydraulic geometry graph (top), Drainage analysis (middle),
Tuflow output for proposed tidal crossing (bottom)

- ❧ Focus on Hydrology
 - ❧ Accurate elevation critical
 - ❧ Visualization important
- ❧ Graham, 2012
 - ❧ Hydraulic geometry
 - ❧ Characterize drainage networks
- ❧ Hydrodynamic modeling
 - ❧ Complex systems
 - ❧ Scenario tests
