October 21 - 22, 2015 | Fredericton, New Brunswick, Canada

Use of Analytical Estimates and Water Balance Components to Estimate Leakage Rates Through Cover Systems Utilizing a Geomembrane

By: Greg Meiers

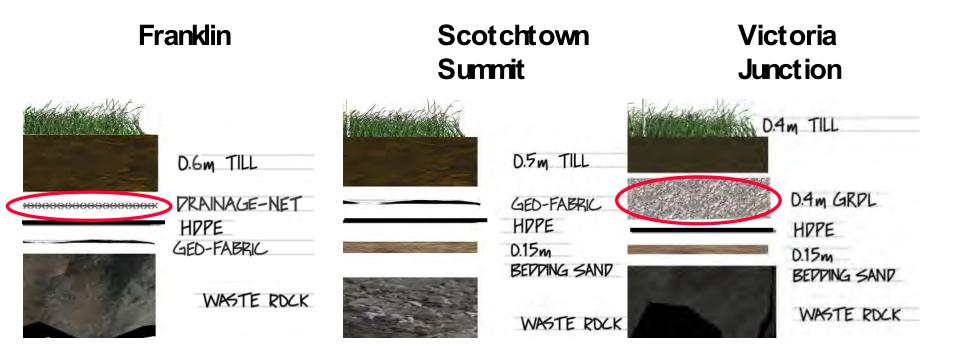
Cover System Profiles

- Similar Growth medium ~0.5m thick and geomembrane
- Different Franklin and VJ include a drainage layer

Drainage Net

No Drainage

Granular Drainage

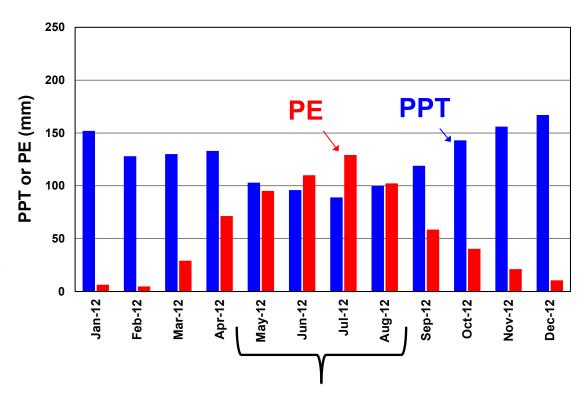
Typical Site Climate Conditions

- Mean annual PPT is ~ 1,500 mm
 - 60% occurs in Winter (from October to March)
 - ~50% of winter PPT is snowfall
- Mean annual PE ~700 mm
- Energy deficit in most months

Some Atmospheric Demand for Water In Summer

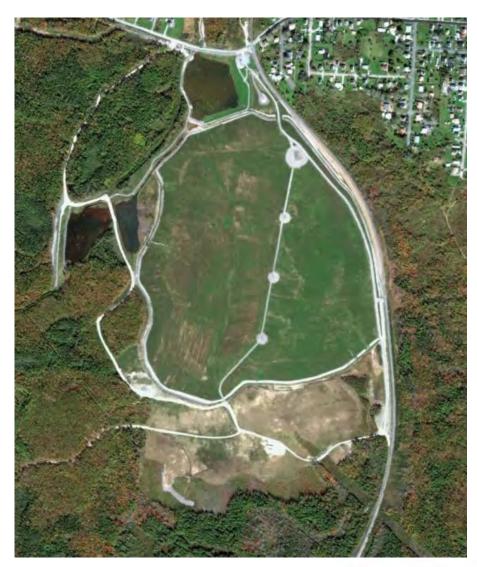
Reclaimed Summit WRP

- Covers an area of 44 ha
- Thickness of 1.5m to 10m
- Plateau 3% slope transitioning to 7:1 side slope
- Runoff ditch constructed around perimeter

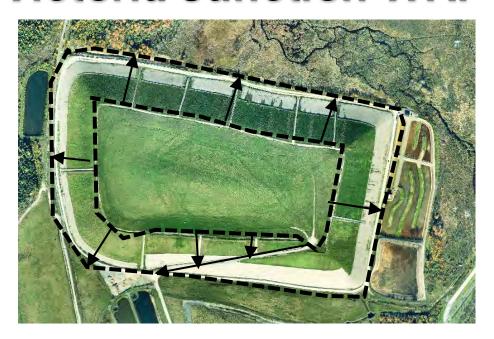
Reclaimed Victoria Junction WRP

- Covers an area of 26 ha
- Height of 40m
- Plateau ~7%
- Side Slope 3:1
- Runoff ditch constructed around plateau which channels runoff to drop structures on side slope

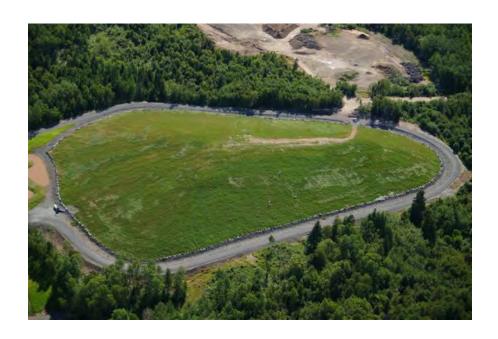
Reclaimed Franklin WRP

- Covers an area of ~2.5 ha
- Height of 13 m
- Gently sloping platea
- Side Slope 4:1
- Runoff ditch constructed around perimeter

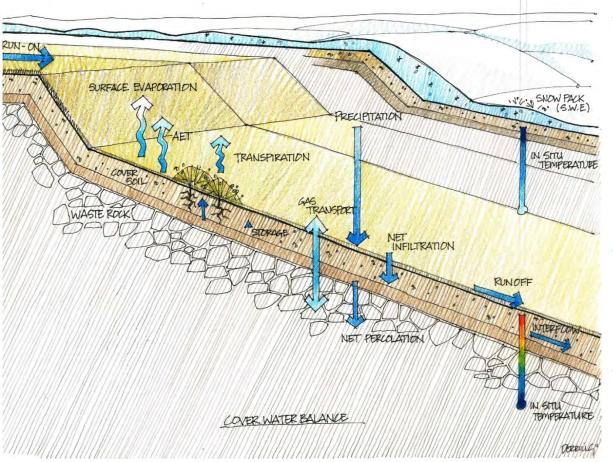
In Situ Direct Cover Monitoring

- Monitored water balance component:
 - AET
 - PPT
 - Runoff
 - Interflow
 - Water Storage
 - Net Percolation (NP)
- NP Estimated through:
 - Water Balance
 - Analytical Estimates
 - Conservative Tracer
- Internal WRP Monitoring System:
 - **Temperature**
 - Pressure
 - **GW Elevations**
 - **Pore-Gas Concentrations**
 - Pore-Water Quality

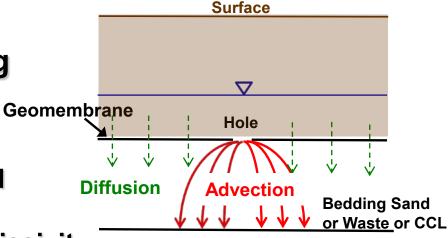
Simulate Net Percolation

- The head of water that develops above a geomembrane is a key parameter for estimating leakage and can be:
 - 1) Measured directly
 - 2) Estimated using measured Description In the lateral drainage above the geomembrane and transmissivity
 - 3) Estimated using water balance and transmissivity of drainage layer
- Simulated net percolation over a range of defects
 - > 2 and 30 defects/ha each at 9mm in diameter

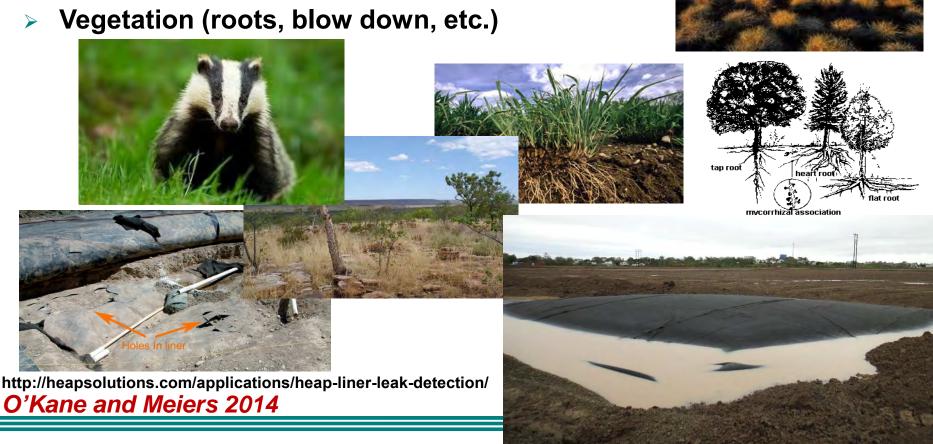
Geomembrane Defects

- Construction (wrinkles, tears, welds, punctures, ...)
- **Post Construction**
 - Services stress (differential settlement, Δ temp)
 - **Anthropogenic (e.g. artisanal mining)**
 - **Bioturbation**

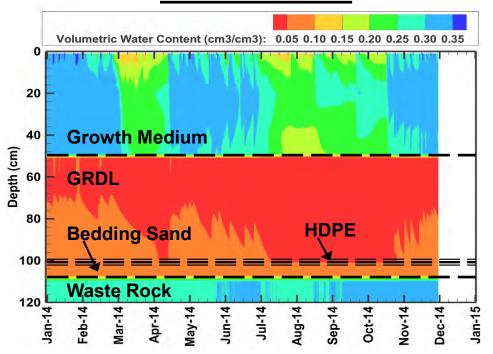
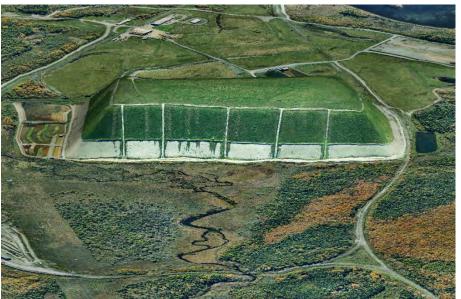
Water Dynamics – Victoria Junction

- GRDL at VJ limits head of water above geomembrane
- Approximately 15% of precipitation moves through the GRDL

Runoff and lateral drainage from plateau is brought back to surface and channeled to drop structures on side slope

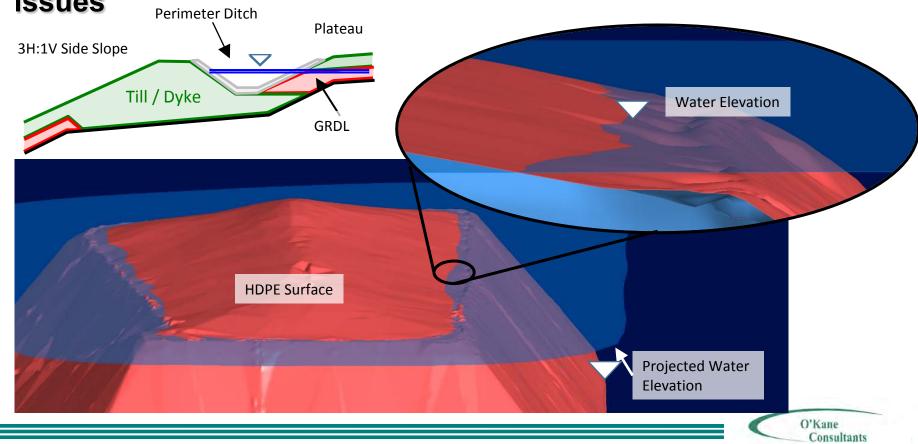
VJ - Direct Cover Monitoring

- Lateral drainage capacity is adequate... however a restriction to flow at the outlet to the GRDL
- Flow restriction affects ~ 6% of landform surface
- Informs on potential for and risk of leakage and stability issues

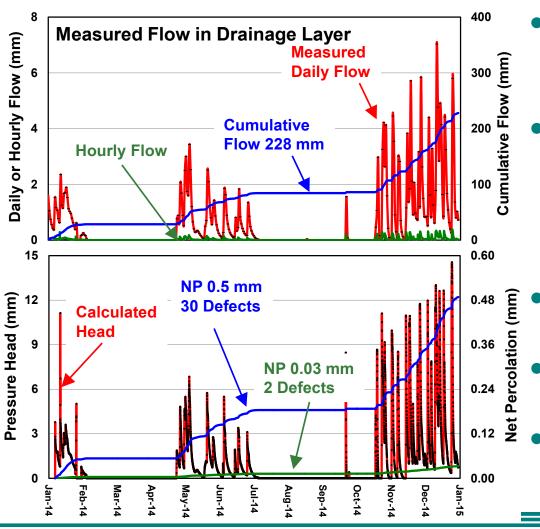
Simulated Net Percolation – VJ

Initial conceptual model – Potential for and risk of NP is lowneed to consider restriction to flow at GRDL outlet

- Measured lateral flow in GRDL used to estimate head
- Growth medium attenuates flux to GRDL (max 8x10⁻⁶ cm/s or 0.3 mm/hr)
 - Highlights importance of the growth medium layer
- Maximum head is ~12mm, supports transmissivity
- Simulated NP...Is very low <1mm
- Risk associated with leakage is low

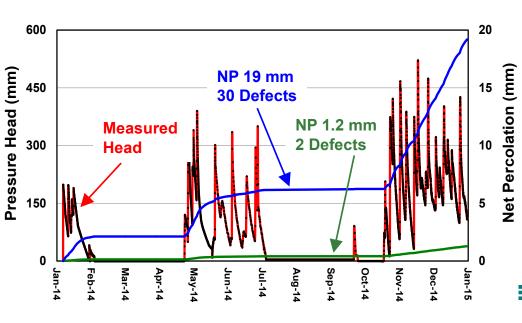
Simulated Net Percolation – VJ

Initial conceptual model – Net percolation in very low rangeneed to consider restriction to flow at GRDL outlet

- Used measured head in GRDL used to estimate leakage
- Maximum head is >450mm
- Simulated NP, <19mm for the area of restricted flow

Daily Flux Rate (cm/s)	Head (mm) –	Defects per hectare		
		2	15	30
		Net percolation (mm/yr)		
Adequate drainage (94% of surface and 30% of total NP)				
transient	transient	0.03	0.2	0.5
Inadequate drainage (6% of surface and 70% of total NP)				
transient	transient	1.2	10	19
Landform				
		0.1	8.0	1.6

- ~6% of surface area contributes 70% of total NP
- Simulated landform NP, very low < 2mm
- Risk associated with leakage through defects low

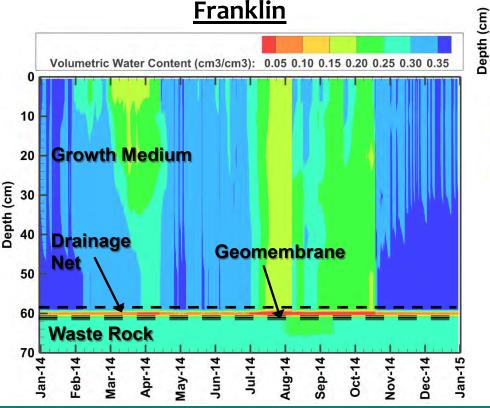
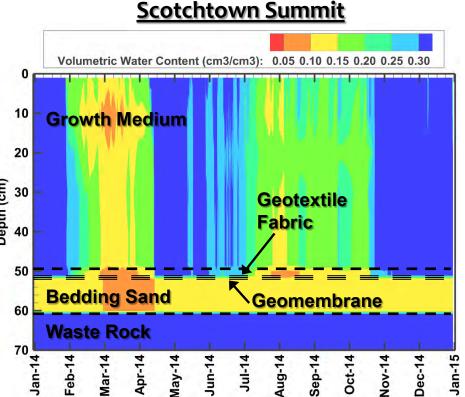
Water Dynamics – Franklin & Summit

- Franklin Drainage Net limits head of water above geomembrane
- Summit Transmissivity inadequate to limit head of water

- Summit cover system inherently carries a greater risk of leakage
- Conceptual understanding of performance is established

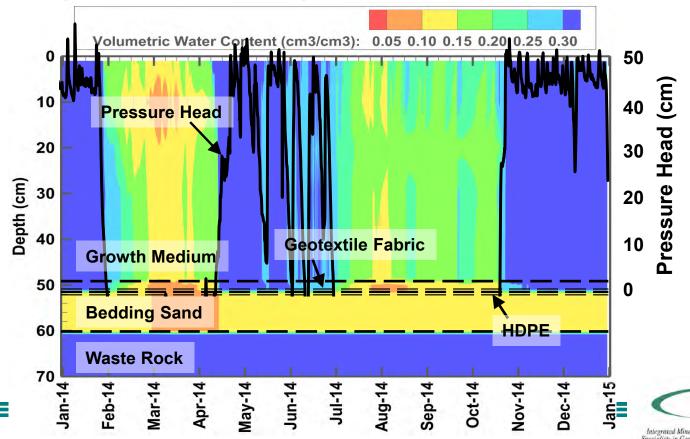
Hall Hydraulic Head – Summit

- Inadequate lateral drainage capacity to limit head of water above geomembrane
- Enhance understanding of risk associated with leakage
- Transitions rapidly from positive to negative pore-water pressure (~14 mm or water)

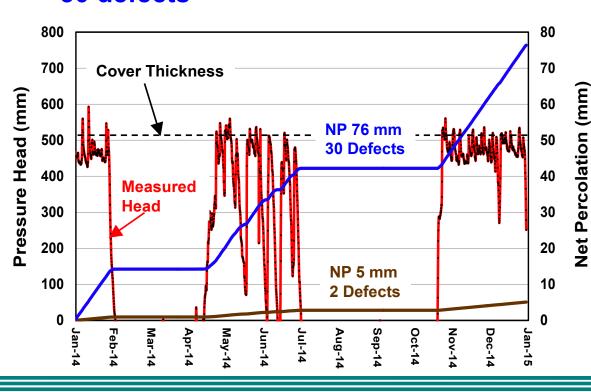
Summit: Simulated Net Percolation

Initial conceptual model – Risk of NP associated with defects

- Use measured head
- Maximum head is >500mm over prolong periods
- Simulated NP, 76mm or 5% of PPT for 30 defects

- Risk associated with leakage through defects is much higher Defects are a concern!
- ARD/ML loading to the receiving environment would be different under the simulated range of NP
- Require additional interpretation of field performance to provide context for NP...

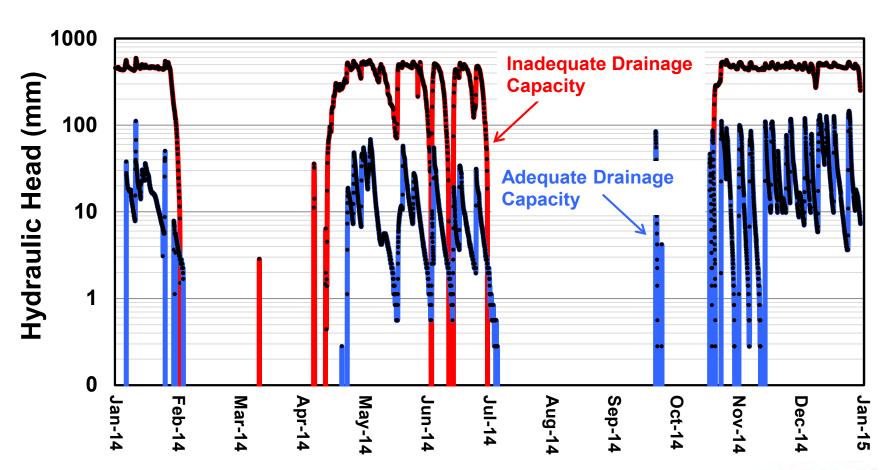
Design Consideration...

Decrease in Ks of drainage layer from 1 cm/s to 0.1 cm/s
