Giant Mine
Remediation Project

The Long Road to Reclamation
Atlantic Reclamation Conference
October 2016

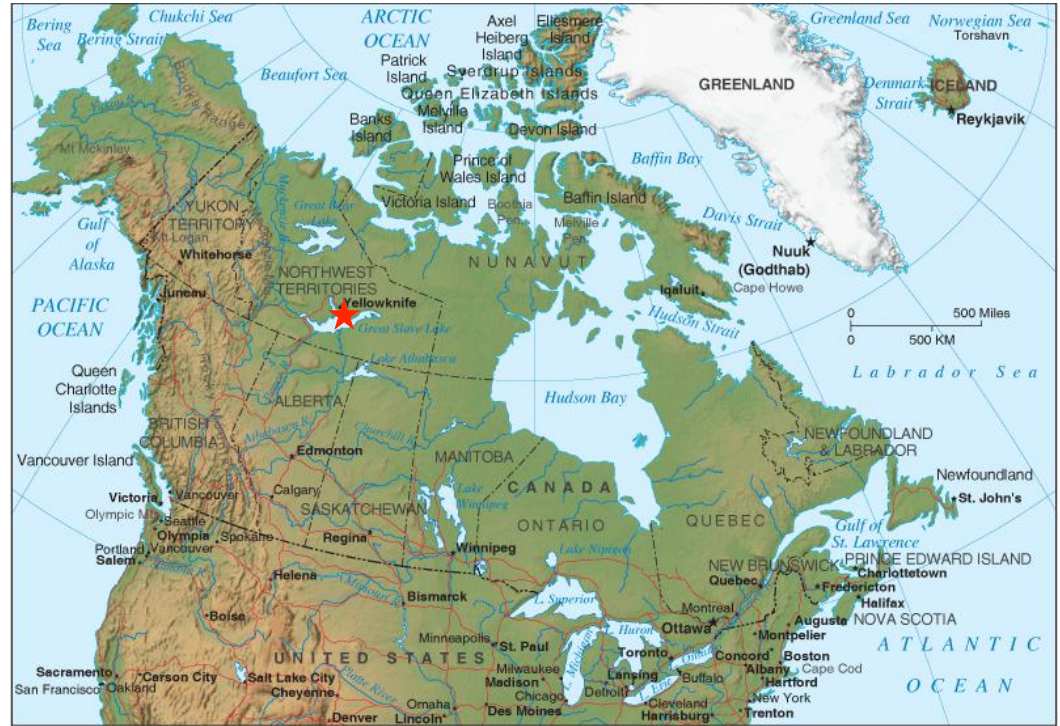
Site Location

- Site is approximately 900 hectares in size
- Larger than several small towns in Nova Scotia
- Located 5 km from urban centre of the City of Yellowknife, Northwest Territories

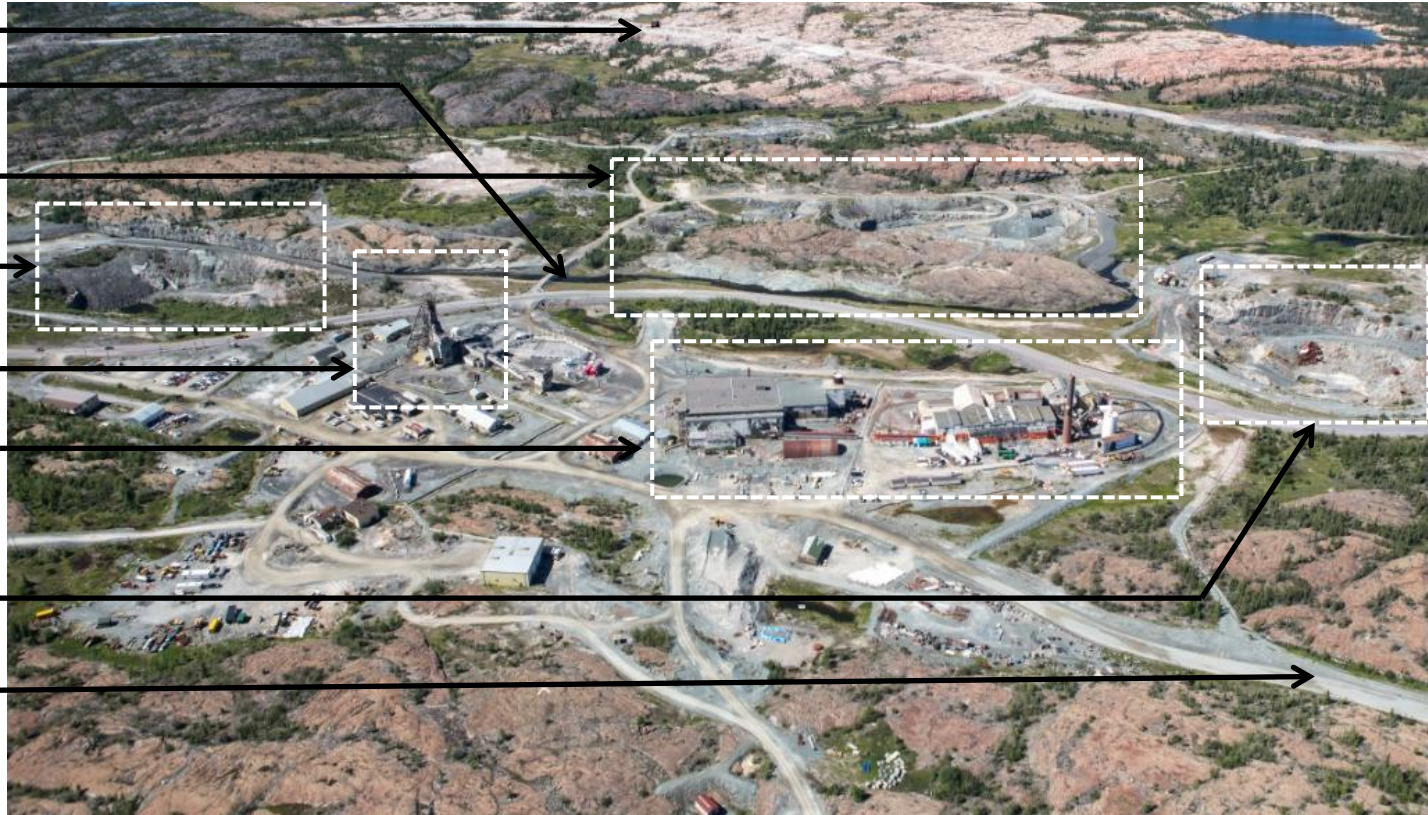
Site Features

Highway 4 (Ingraham Trail)

Baker Creek

B-2 Pit

C-1 Pit

C-Shaft Headframe

Former Roaster Complex

B-1 Pit

To tailings ponds &
water treatment plant

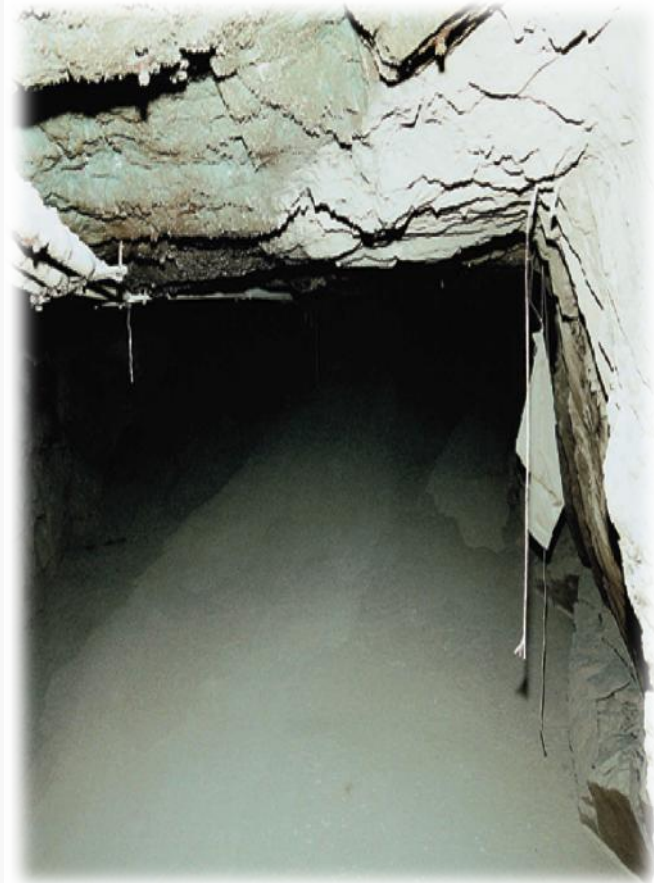
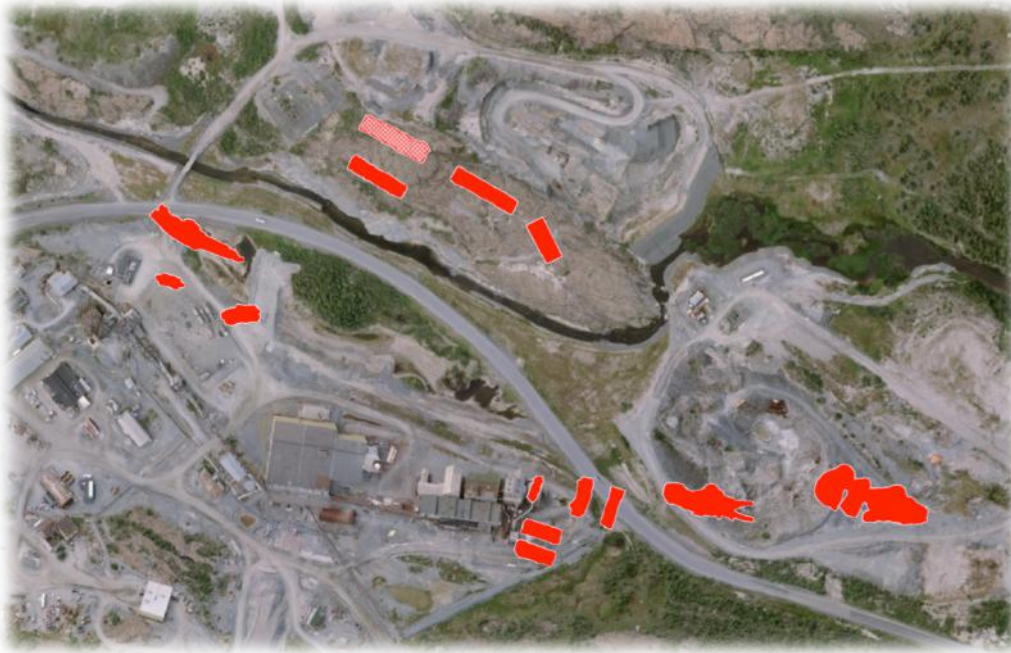
Arsenic Trioxide

- Arsenic trioxide dust created during roasting process (as a result of minimizing arsenic emissions in air discharge)
- 237,000 tonnes of arsenic trioxide dust generated during mine operation
- A dry powder, the consistency of fine flour
- On average contains 60% arsenic trioxide
- Highly toxic and dissolves in water

- Dust was pumped pneumatically into the underground
- Used 3 mined out stopes (irregular shapes)
- Also 11 purpose-built chambers (rectangular shapes), one of which is empty
- 30 – 100 m below surface

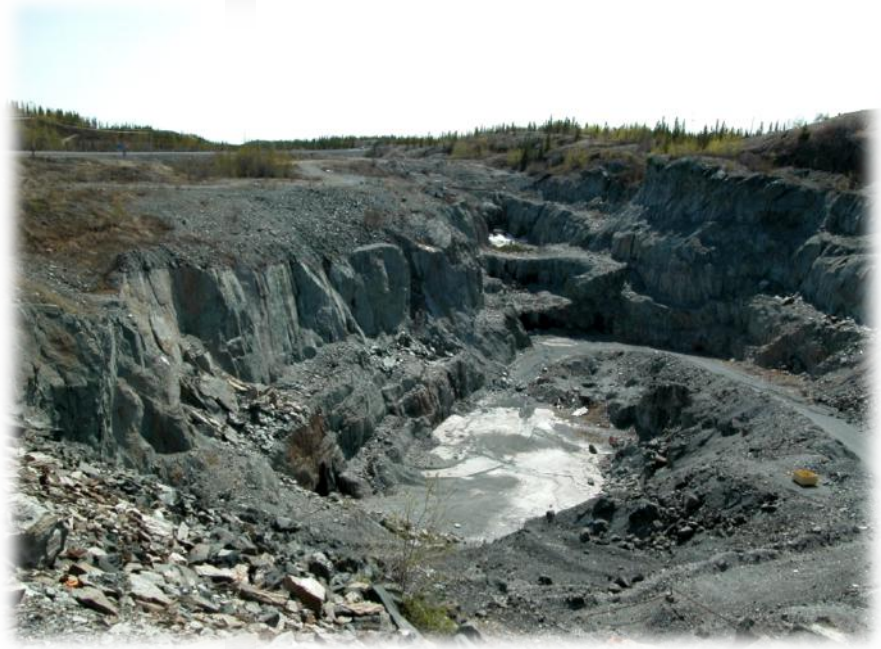
Open Pits

- Eight open pits on site, with a total volume of 2.2 Million m³
- B1 Pit will be backfilled to support freeze solution
- Possible backfill materials will be contaminated soils, tailings, other on-site material
- Approach for other pits being evaluated following Report of Environmental Assessment

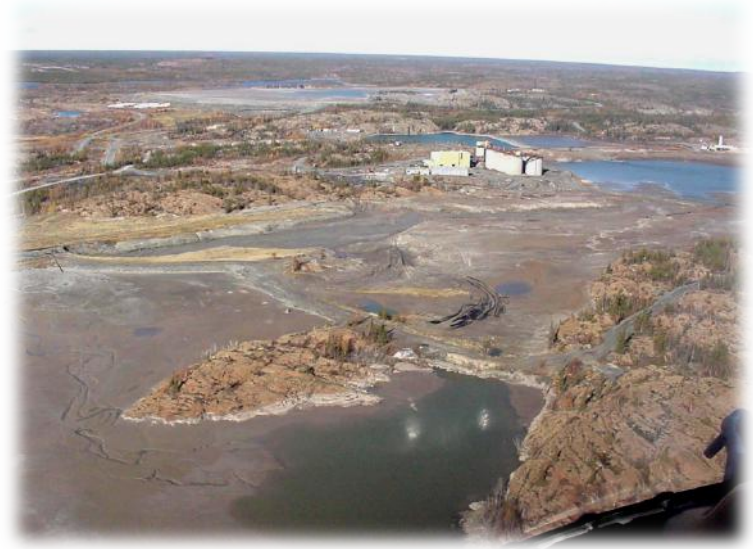
Tailings Management

- 95 hectares of tailings of variable depth and quality
- Tailings cap requirements will be informed by engagement process
- Graded to promote drainage of clean surface water
- Ongoing monitoring and maintenance of caps and dams will be required

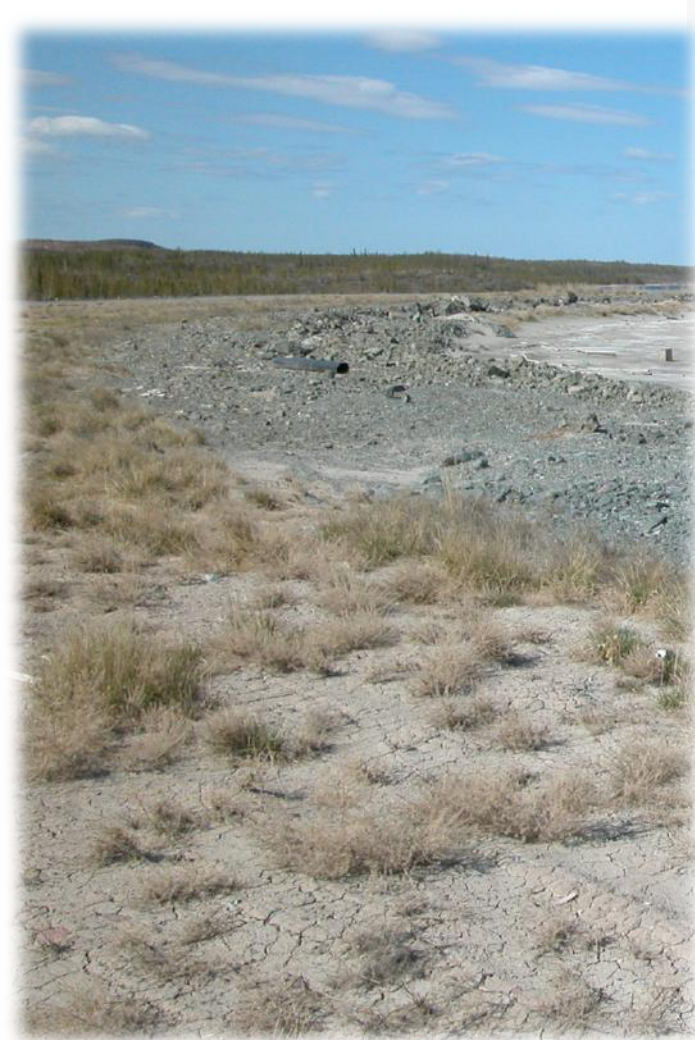
Contaminated Soils

- Approximately 900,000 m³ of arsenic-impacted material in the form of waste rock and disturbed soils
- Minor amounts of petroleum hydrocarbon-contaminated soil (primary diesel from storage tanks supplying generators)
- Remedial approach for soils will be based on results of a Human and Health and Ecological Risk Assessment

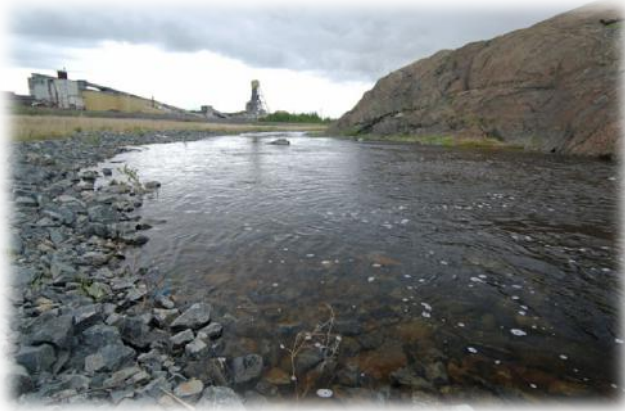
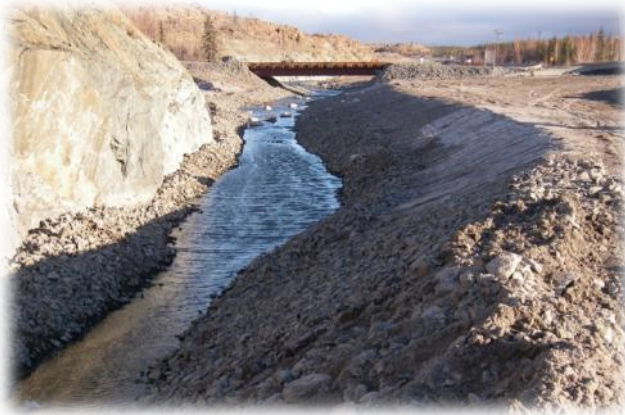
Baker Creek

- Current channel has poor hydraulic capacity; high seasonal flow variability
- Provides fish habitat
- Historic tailings and contaminated sediments
- Potential risk of flooding underground workings
- Realignment being reviewed after Report of Environmental Assessment
