Belledune Point Remediation

Brunswick Smelter

CLRA - October 16-17, 2018

Agenda

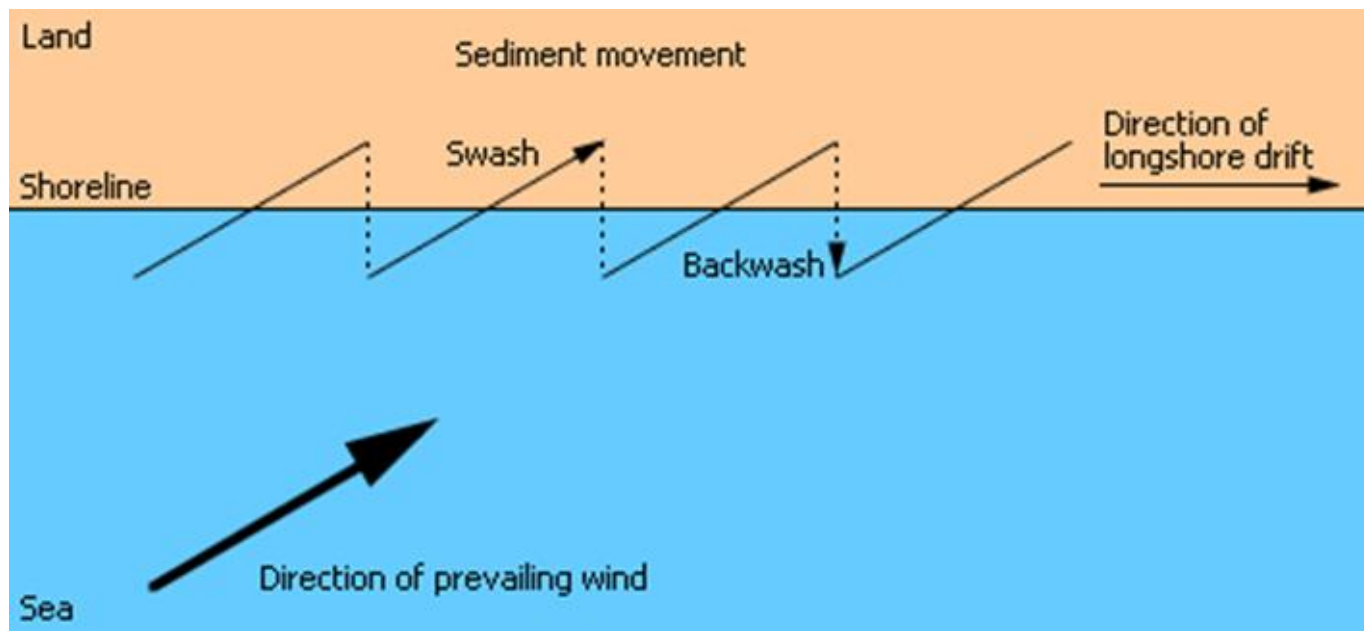
- Belledune Point is a Cuspate Foreland
- Seaward extending triangular shaped accretion of sand and shingle or pebbly rock created by long shore drift.

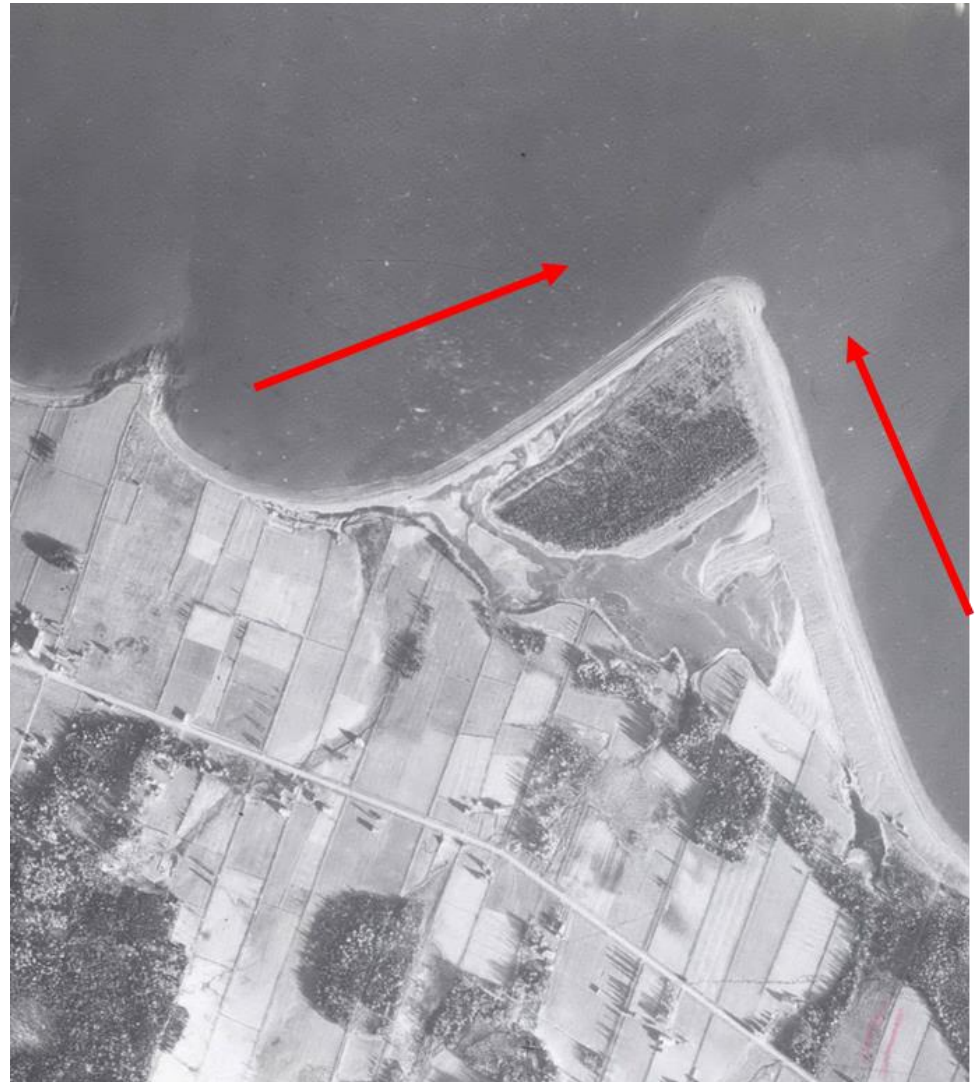
- Belledune Point in 1944
- Belledune Point was stable mainly due to tidal effects
- Belledune Point consists of sand and shingle and was originally stabilised with vegetation

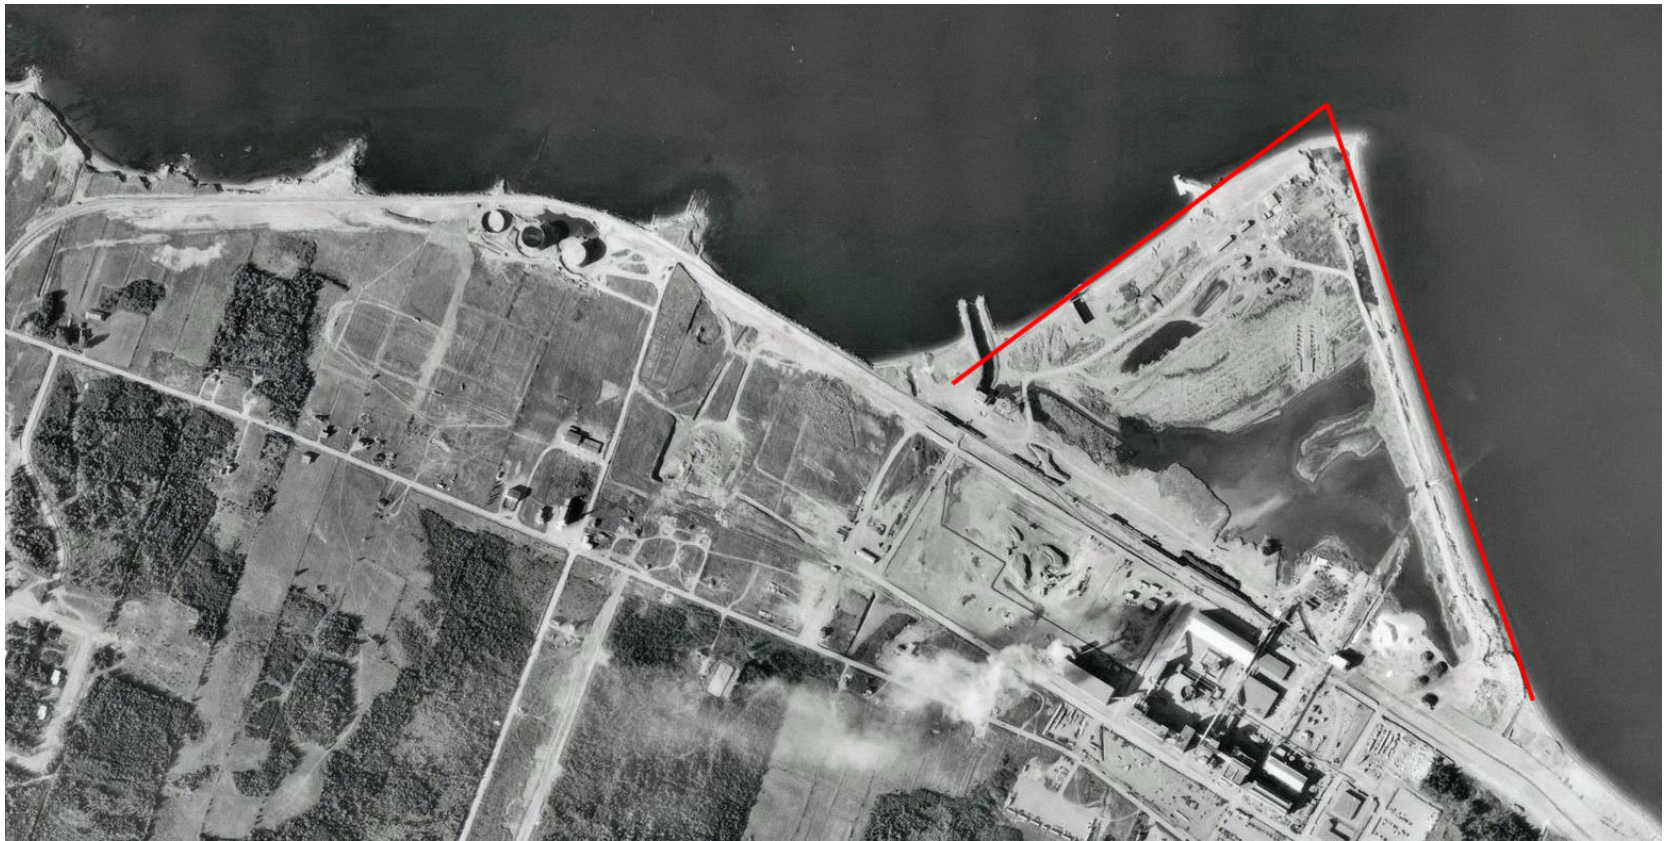
- 1966 the Cuspate Foreland was still stable
- Slag deposition commenced in the wetland depression

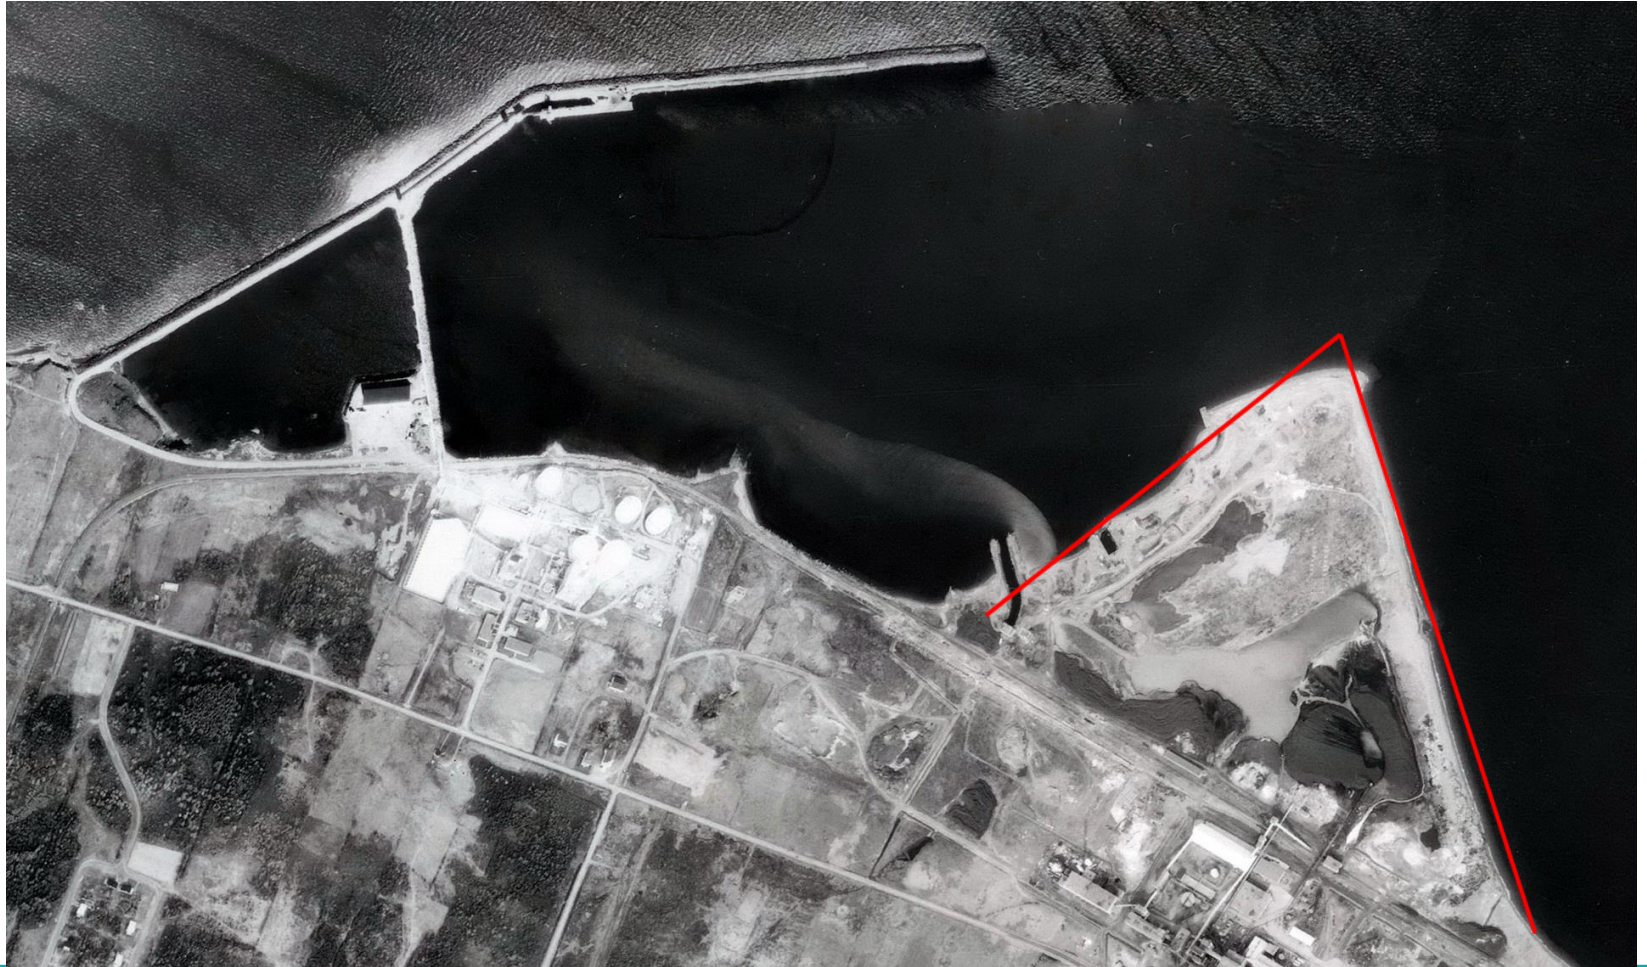
- Construction of Terminal 1 in 1968 changed the Easterly Tidal Effect
- By 1974 one can already see a change in Beach stability

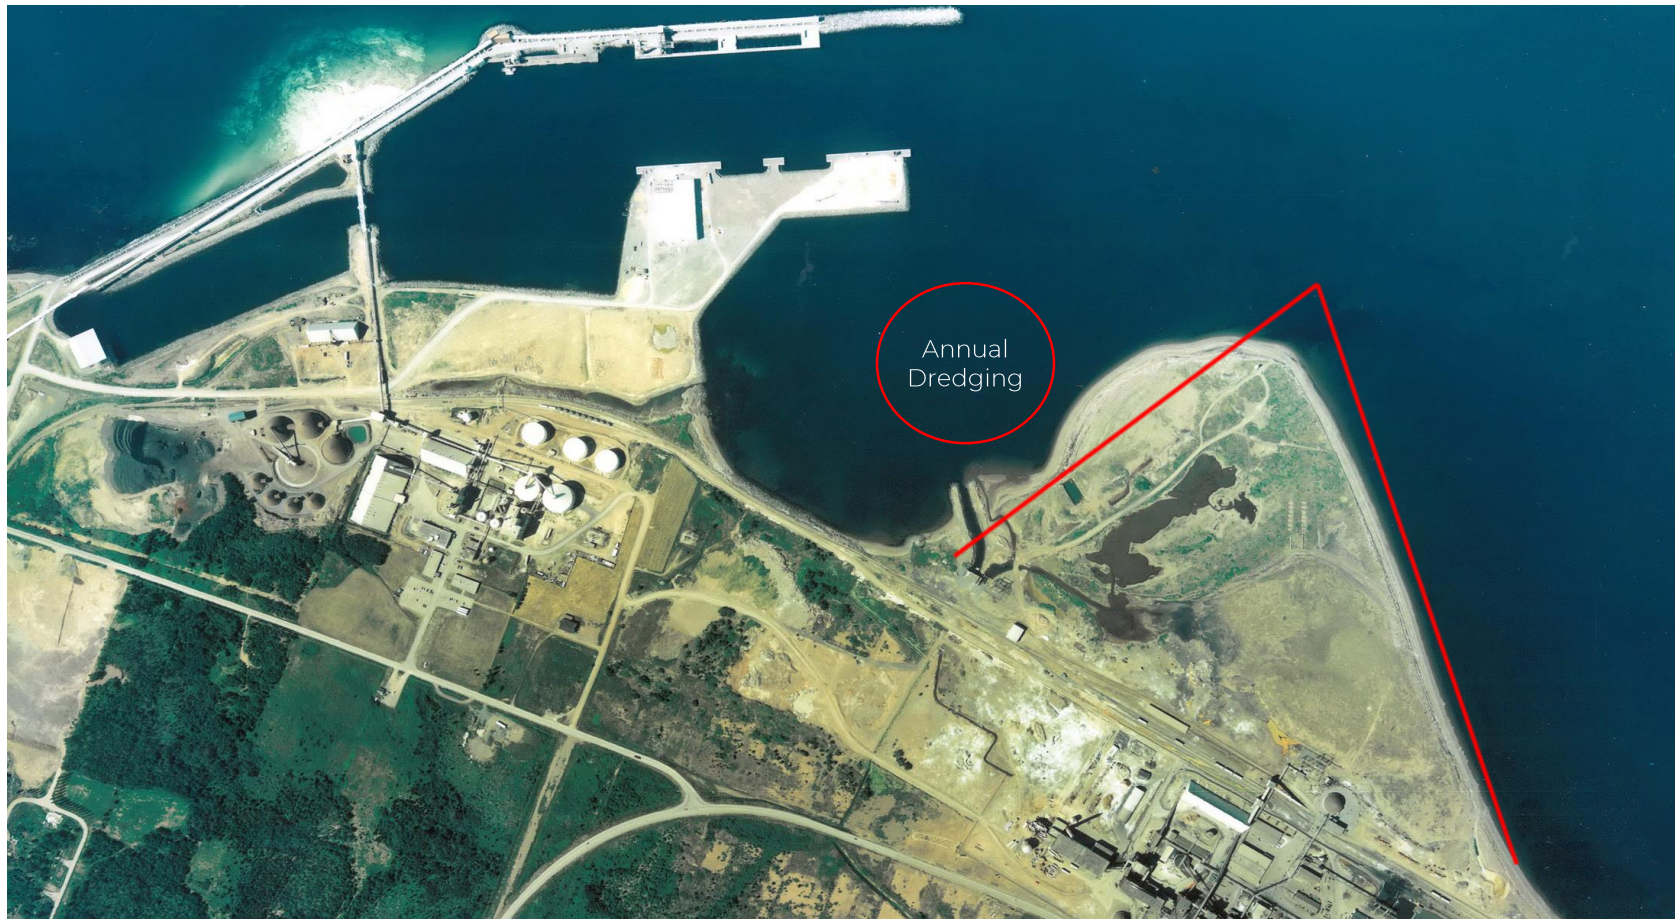
- By 1997, Belledune Point had become rounded
- Early 2000s Brunswick needed to Dredge Saltwater Intake

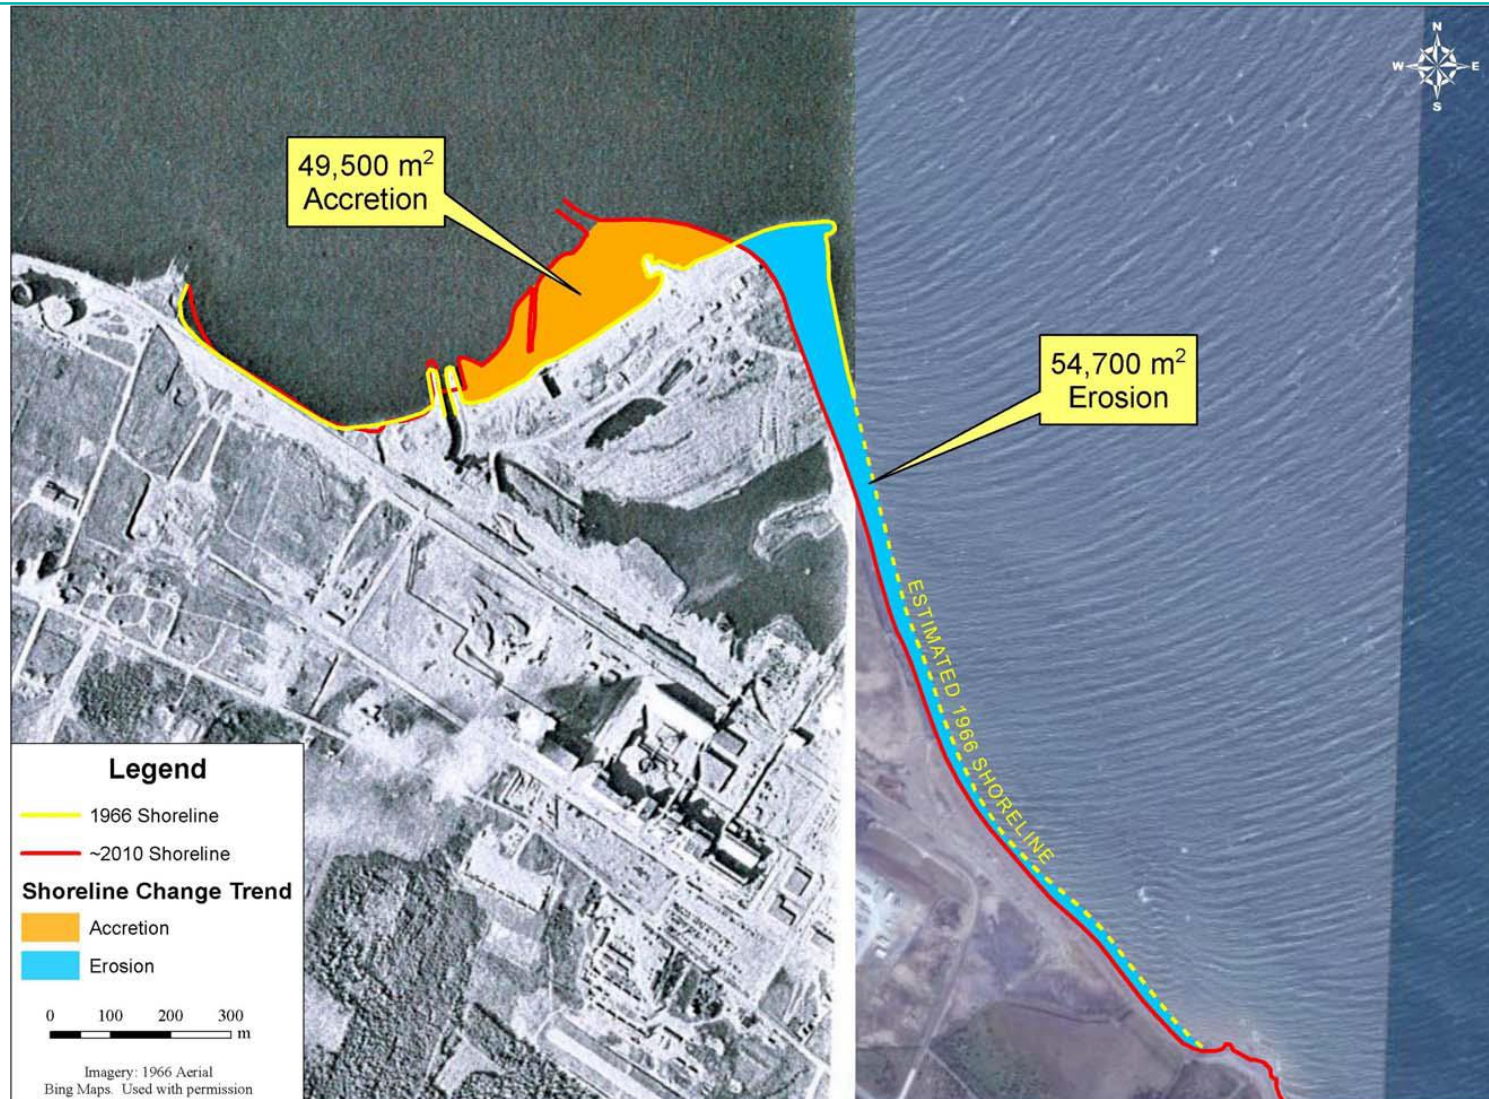
10

Geomorphology – Beach width from 80 m to <10 m

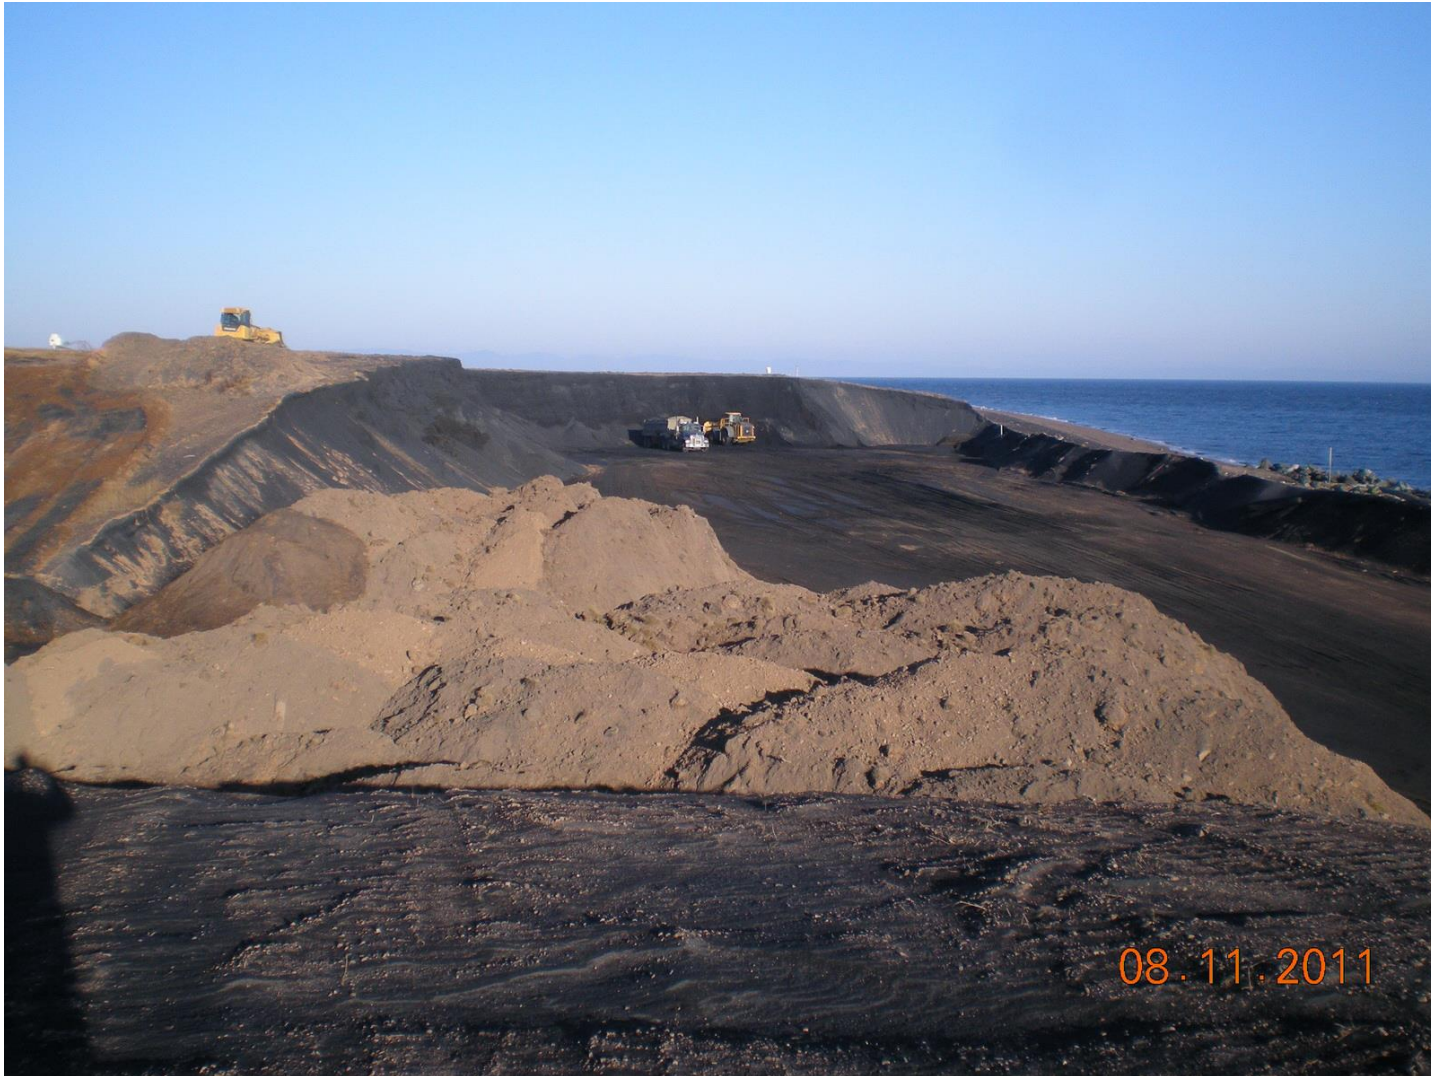
16

Phase I Slag Removal - Nov 8, 2011 – 30 meter bench

- Fall 2011 excavated 150,000 m³ to create 30 m setback for storm protection
- Summer 2012 excavated slag back to clean beach sand (400,000 m³)

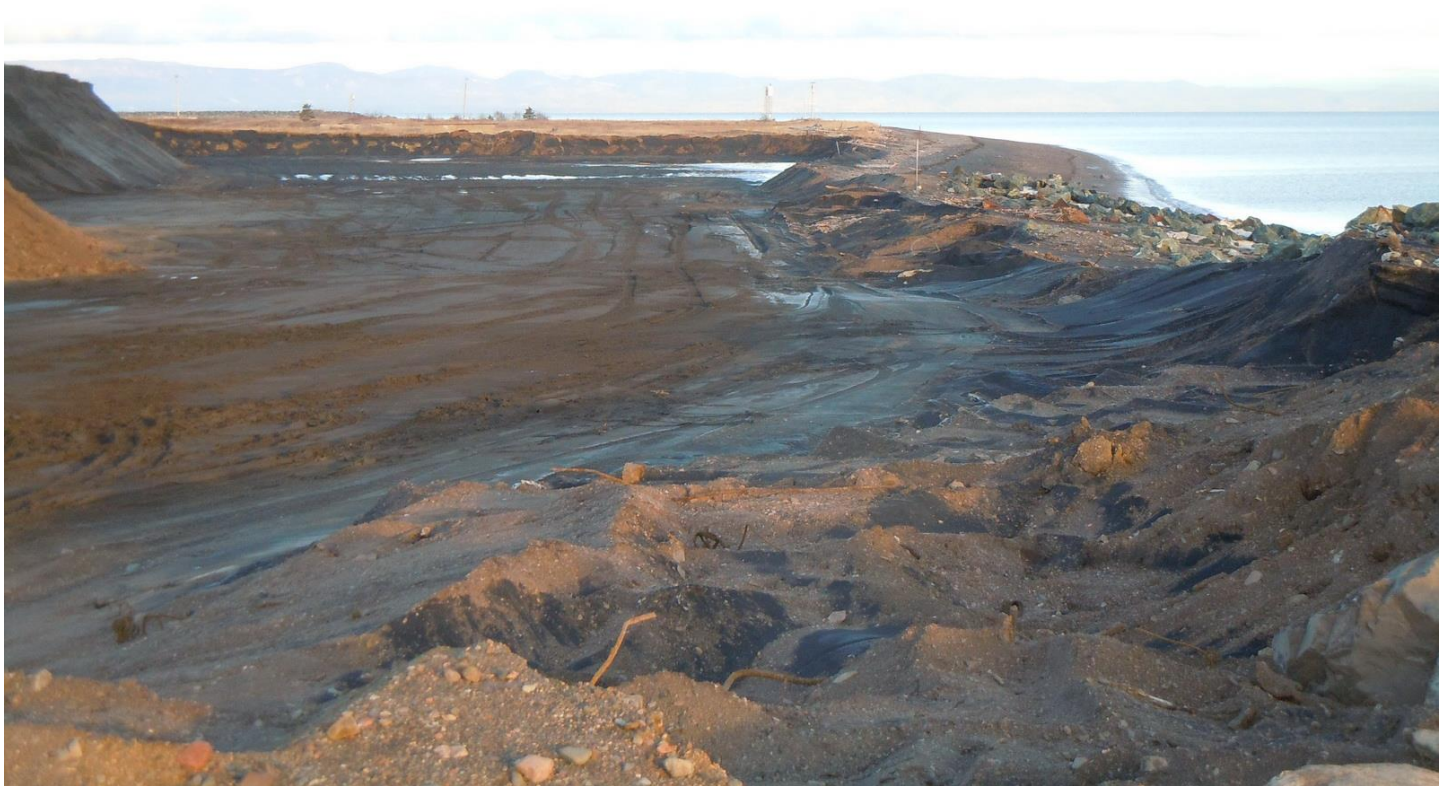
17

Phase I Slag Removal - Nov 7, 2011 – 30 meter bench

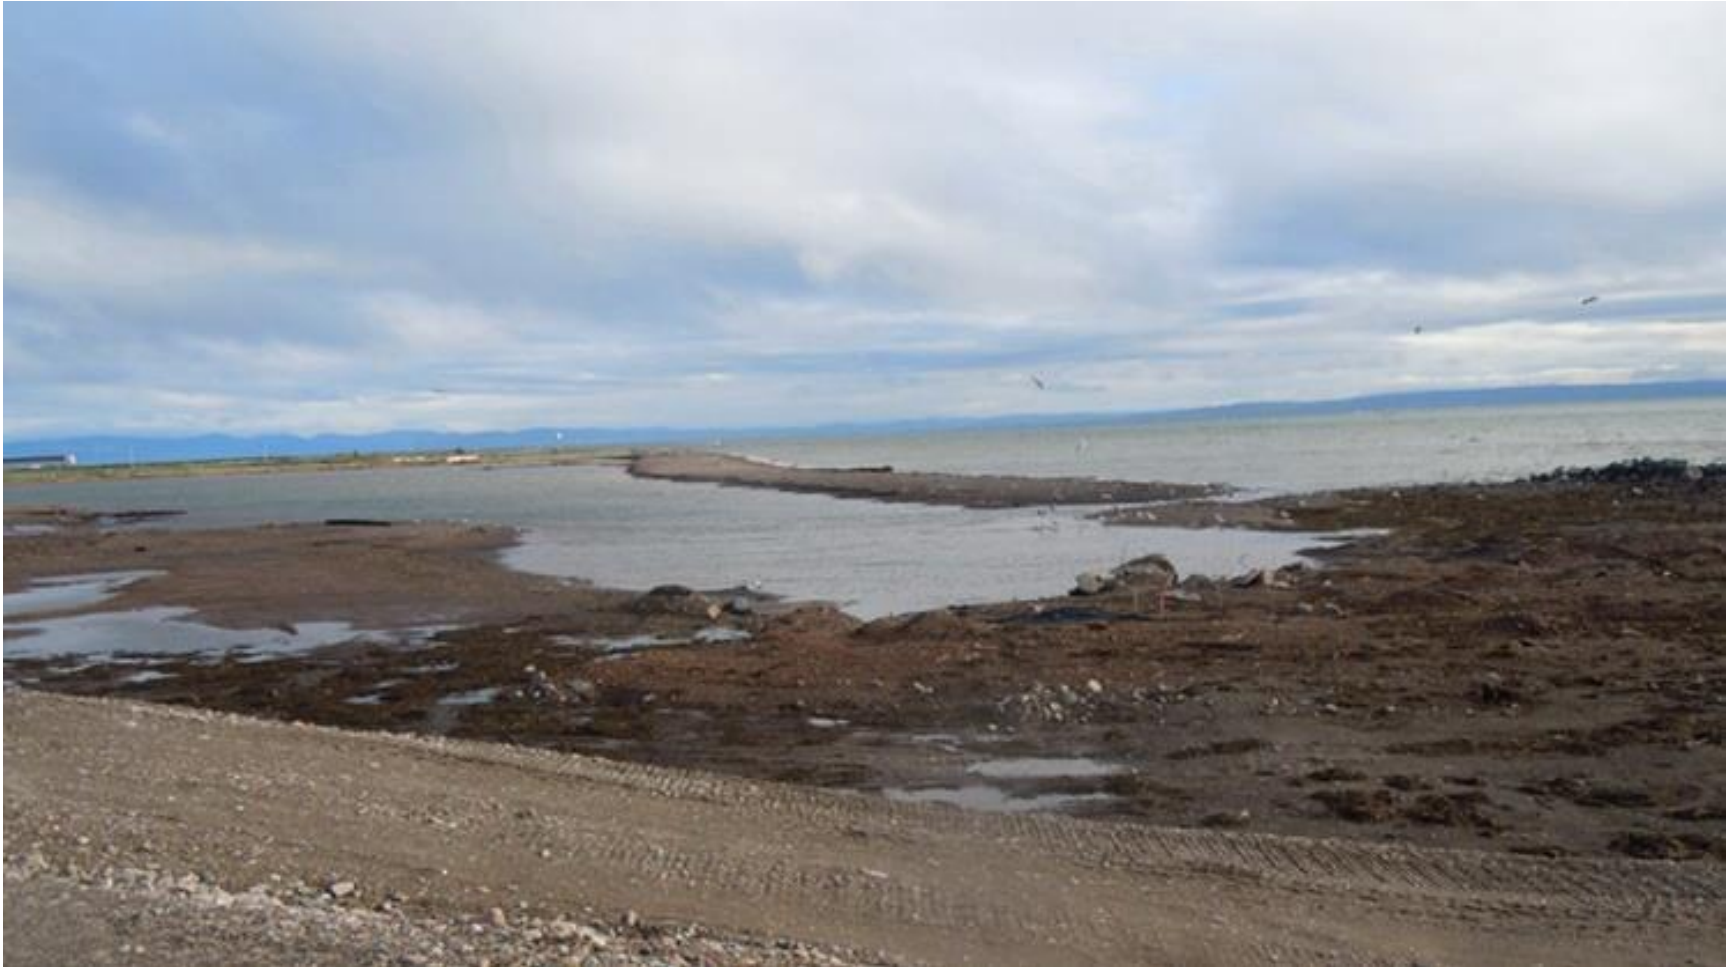
20

Phase I Slag Removal – Oct 31, 2012 Complete
